Table 5 - Summary of XRF Measurement	S
West Haven VA Medical Center, Building	1

Appendix C

Representative Photographs of ACM

Representative Photographs of Non-Intact Lead Containing Paint Greater than or Equal to 1.0 mg/cm

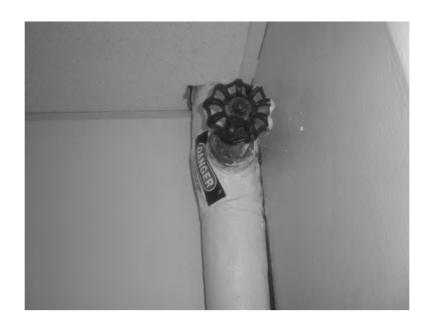
Pipe Elbow Mudded Sample SSG - 7A

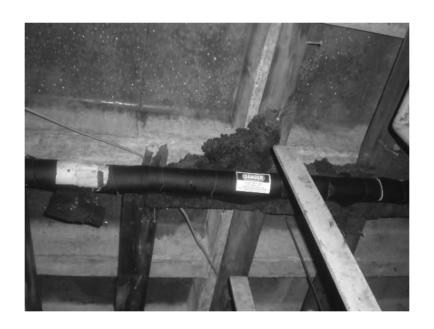
Air Cell Pipe Insulation Sample SSG-14A

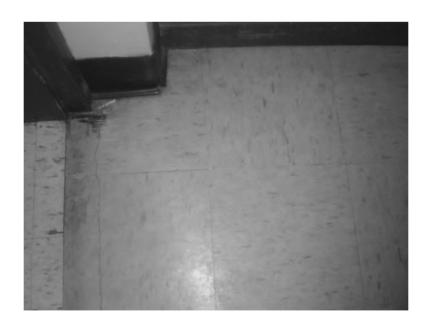
Glue for 12"x12" Cream Floor Tile Sample G - 33A

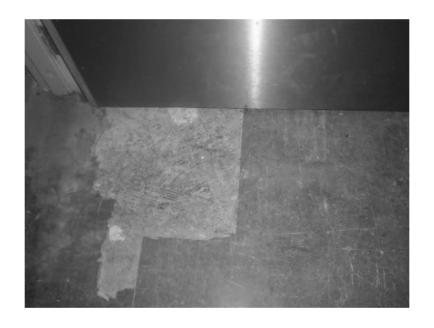
9X9" Red Vinyl Floor Tile Sample G-57A

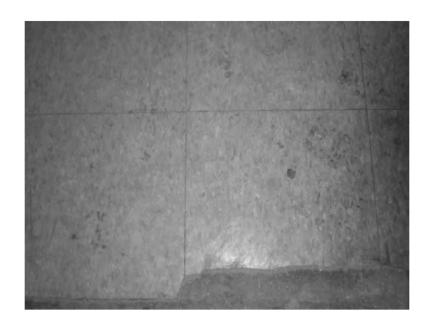
12"x12" Brown Mottled Vinyl Floor Tile Sample G–59A

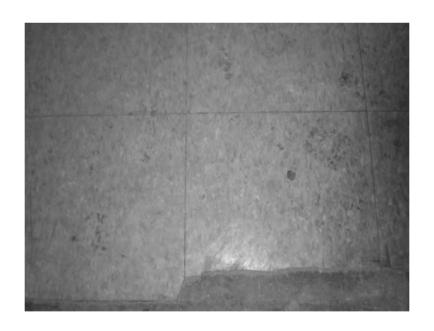
Glue for 12"x12" Brown Mottled Vinyl Floor Tile Sample G - 60A

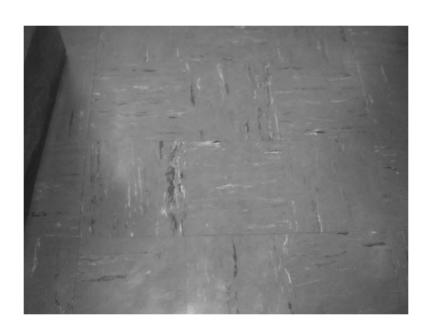
9"X9" Gray Vinyl Floor Tile w/White Specks Sample 1 - 37A

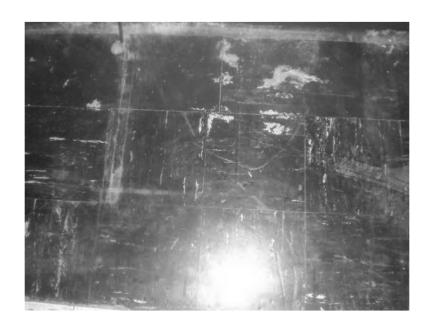
9"x9" Dark Brown Vinyl Floor Tile Sample 1 - 40A

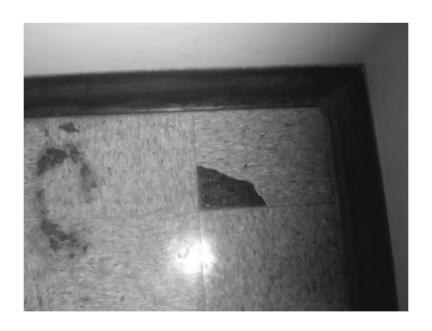
Mastic w/12"x12" Brown Vinyl Floor Tile w/Brown Streaks Sample 1 - 43A

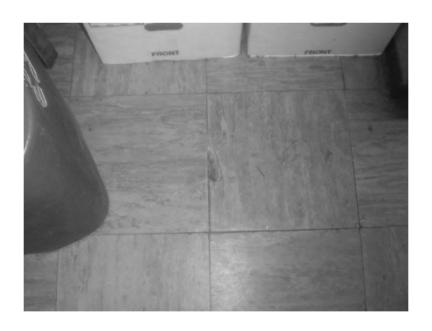
Mastic w/12"x12" Brown Marble Vinyl Floor Tile Sample 1 - 47A

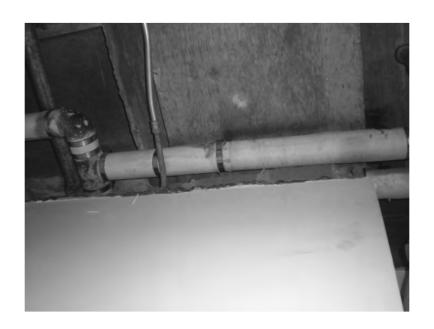
Pipe Insulation, Air Cell Sample 1 - 48A

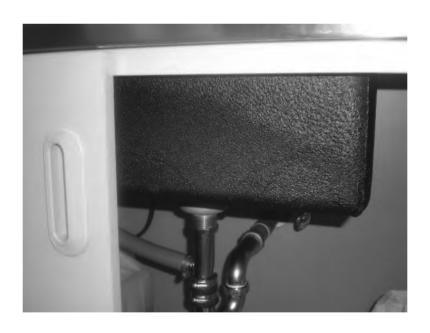
Sink Undercoating Black Sample 1 - 57A

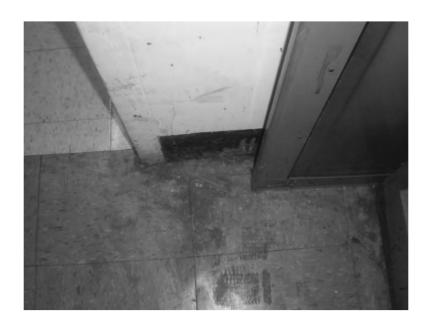
Mastic w/12"x12" Light Brown Vinyl Floor Tile w/Dark Brown Specks Sample 1 - 73A

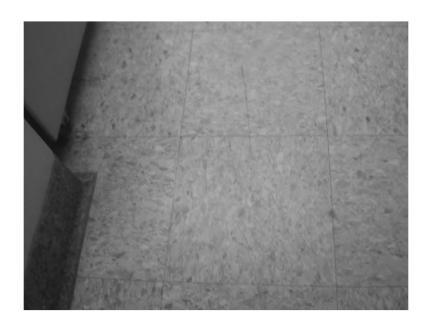
Mastic w/12"x12" Tan Vinyl Floor Tile Stone Pattern Sample 1 - 75A

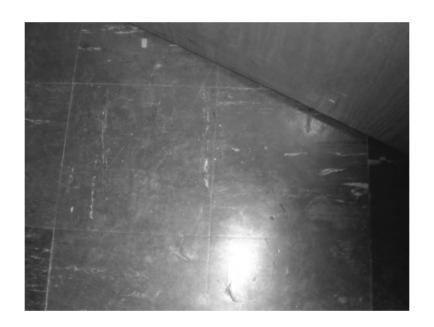
9"x9" Red Vinyl Floor Tile w/White Specks Sample 2 - 24A

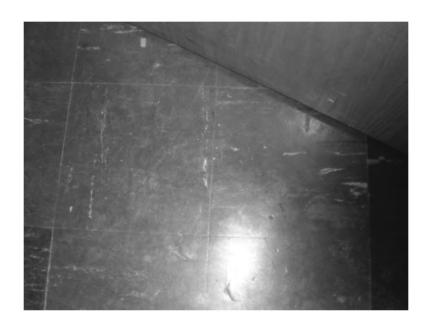
Mastic w/9"x9" Red Vinyl Floor Tile w/White Specks Sample 2 - 25B

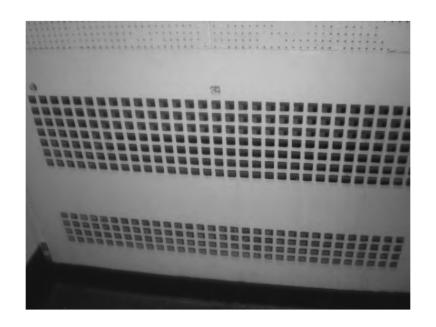
Transite Wall Panel w/Pinholes Sample 2 - 41A

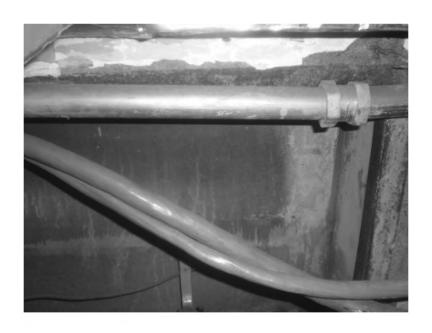
Transite Heat Panel Sample 2 - 51A

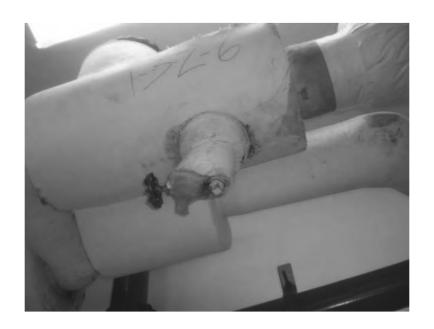
Pipe Elbow Insulation Sample 3 - 22A

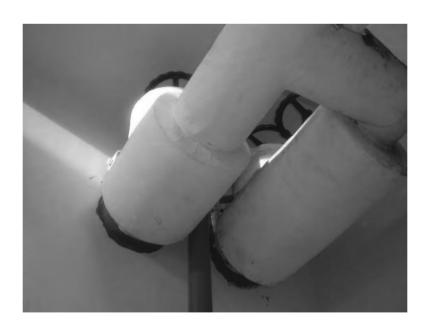
Pipe End Cap Insulation Sample 3 - 23A

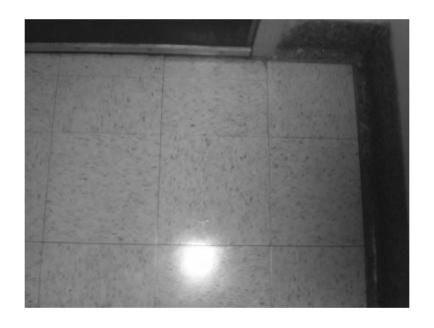
Mastic w/9"x9" Light Green Vinyl Floor Tile w/Gray Specks Sample 4 - 7A

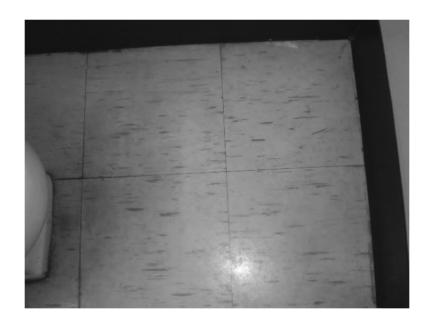
12"x12" Cream Vinyl Floor Tile w/Brown Streaks Sample 4 - 21B

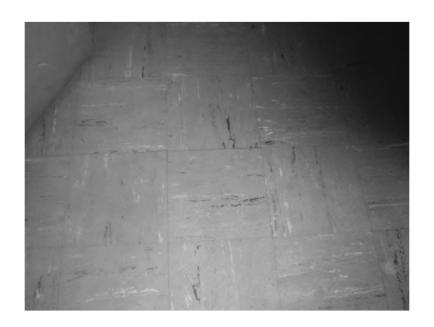
9"x9" Light Brown Vinyl Floor Tile w/Dark Brown Streaks Sample 4 - 30A

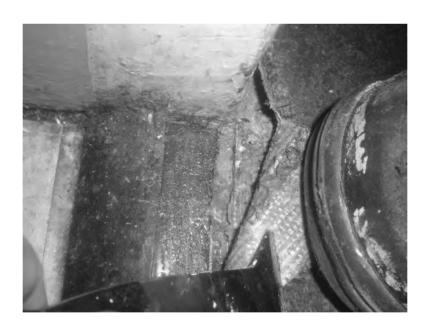
9"x9" Dark Green Vinyl Floor Tile Sample 4 - 52A

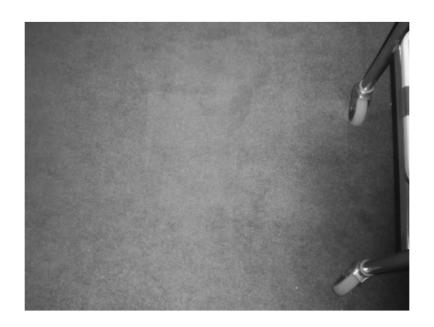
9"x9" Light Gray Vinyl Floor Tile (below carpet) Sample 4 - 54A

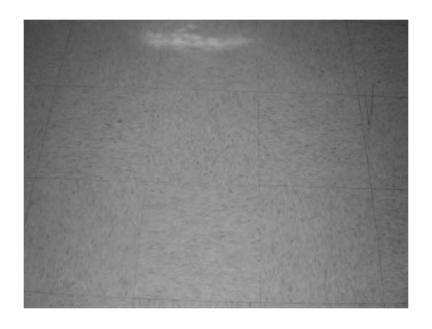
Mastic w/12"x12" Cream Vinyl Floor Tile w/Gray Specks Sample 5 - 29A

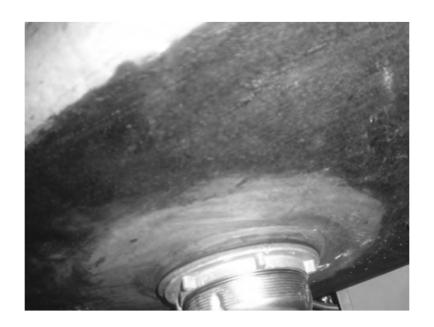
Sink Undercoating Black Sample 6 - 11A

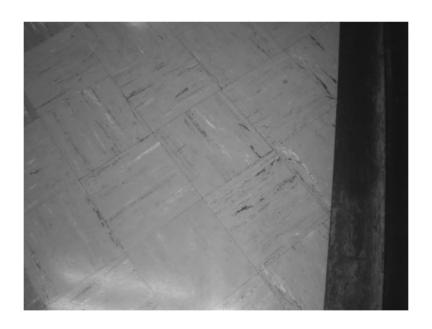
9"x9" Light Brown Vinyl Floor Tile w/Black Streaks Sample 7 - 5A

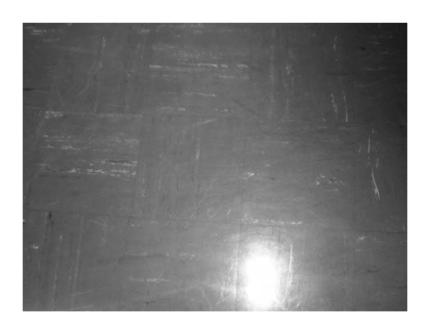
9"x9" Dark Green Vinyl Floor Ceiling Tile w/White Streaks Sample 7 - 7A

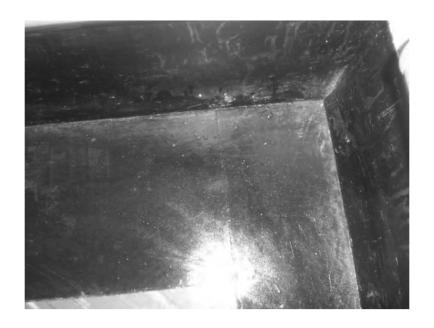
Dark Brown Flooring Border Sample 7 - 28A

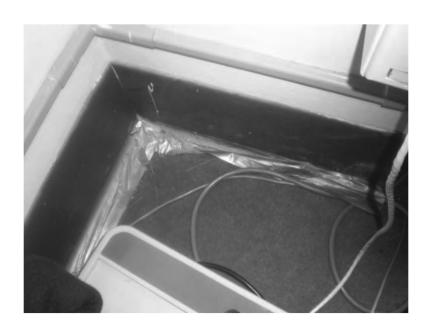
Glue w/Pink Carpet Sample 7 - 40A

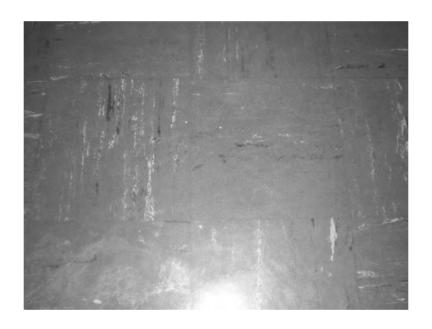
9"x9" Green Vinyl Floor Tile w/White Sample 8 - 15A

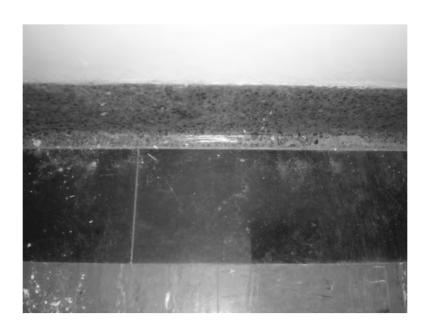
Black Border Vinyl Floor Tile Sample 8 - 17A

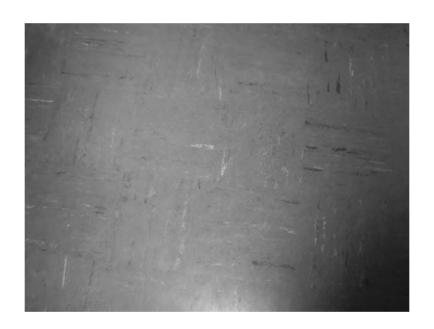
9"x9"' Gray Vinyl Acrylic Tile w Black Streaks Sample 9 - 27A

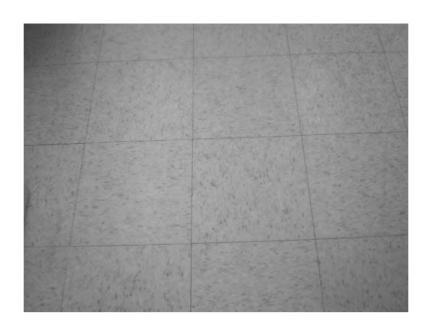
12"x12" Cream Vinyl Floor Tiles w Tan Specks Sample 9 - 31A

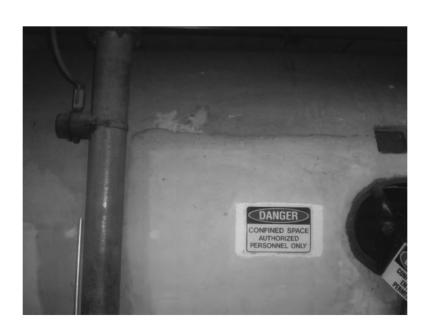
Water Tank Insulation Sample Penthouse - 12A

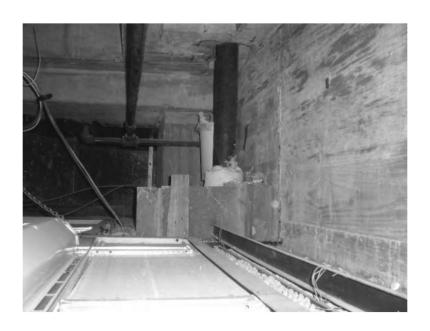
Pipe Fittings Sample AC - G - 8A

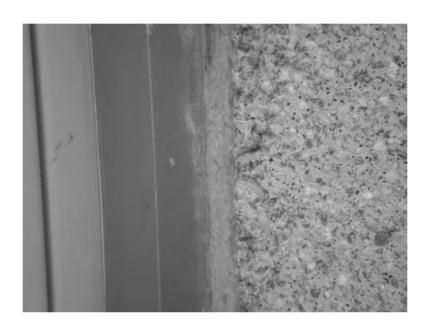
Door Frame White Caulk Sample E - 1A

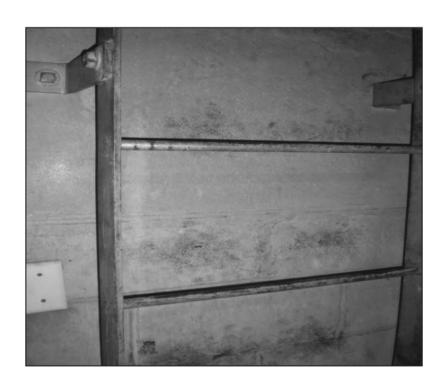
Metal Ladder Sample 9

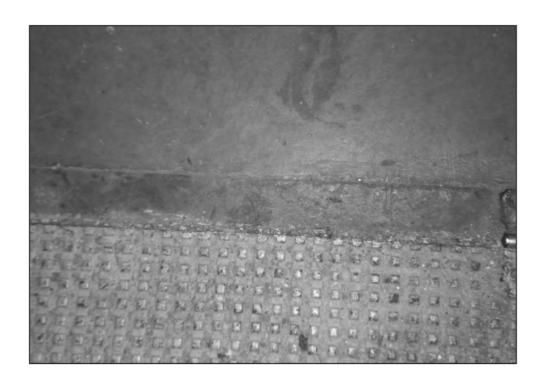
Metal Hatch Casing Sample 17

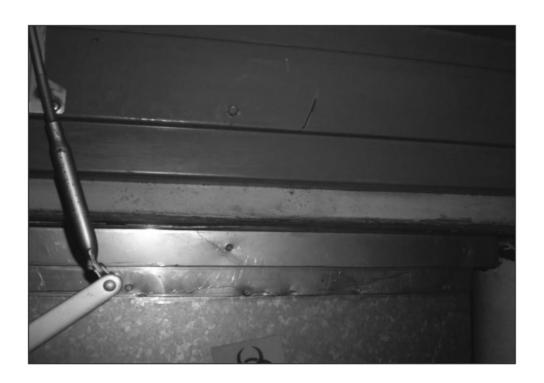
Metal Door Lintel Sample 57

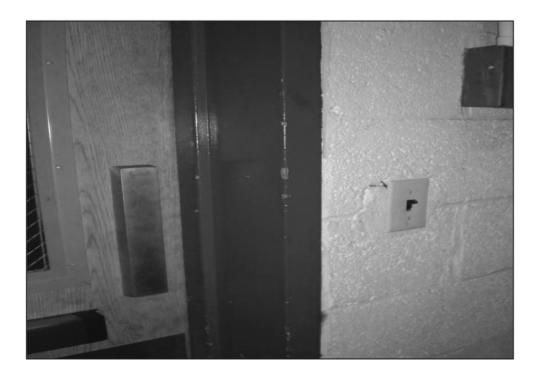
Metal Door Casing Sample 69

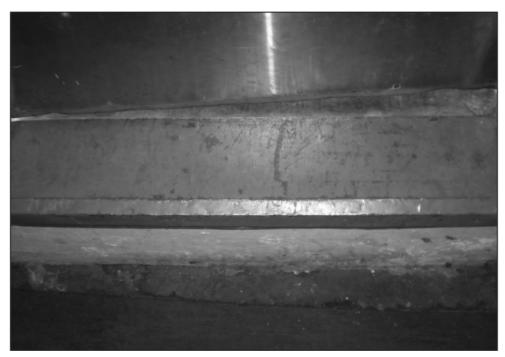
Metal Threshold Sample 86

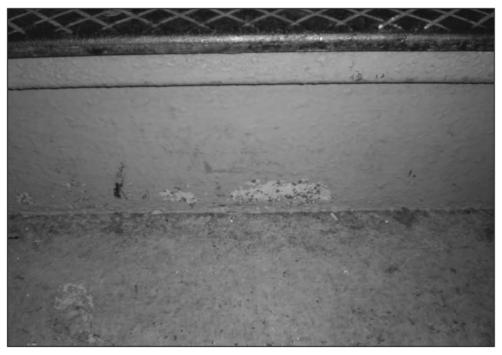
Metal Stair Riser Sample 94

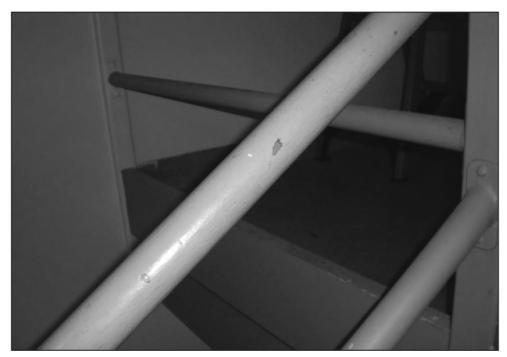
Metal Stair Handrail Sample 97

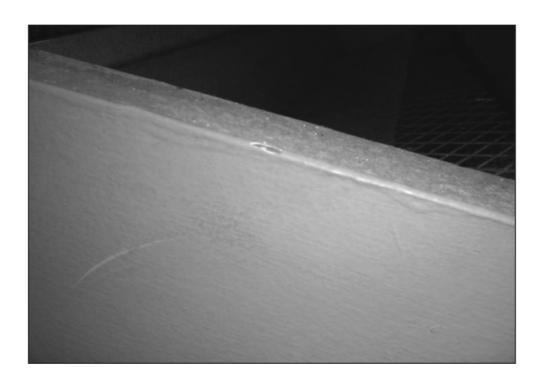
Metal Stair Stringer Sample 105

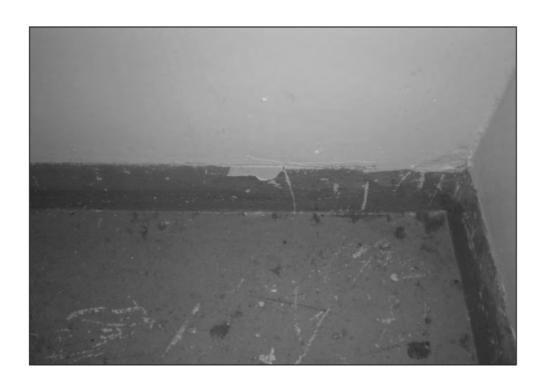
Metal Stair Baseboard Sample 133

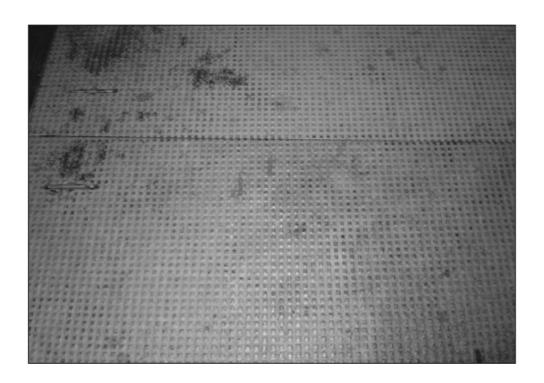
Metal Hatch Sample 134

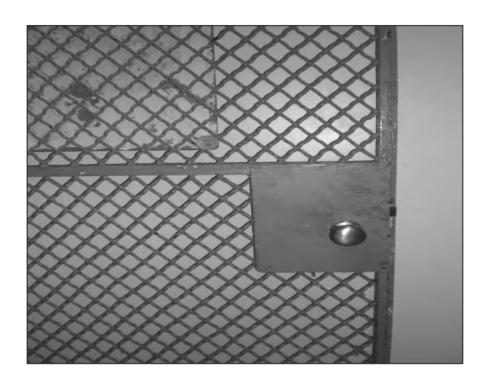
Metal Gate Door Sample 135

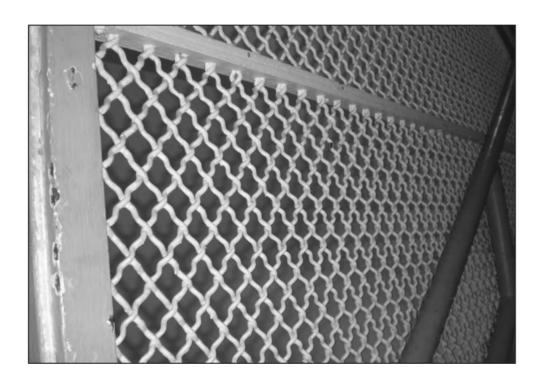
Metal Gate Sample 136

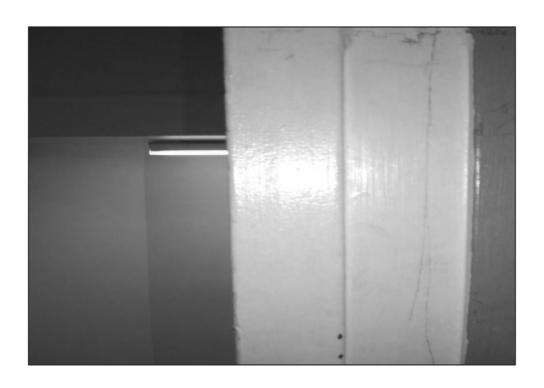
Metal Trim Sample 137

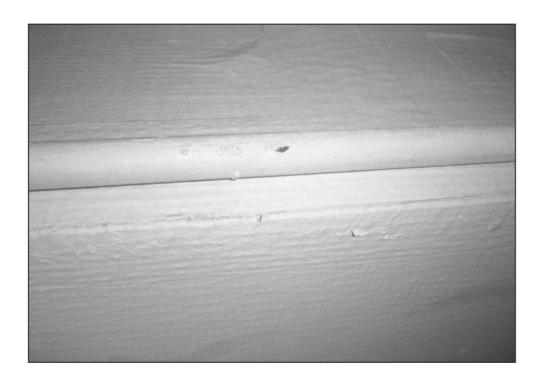
Metal Pipe Sample 327

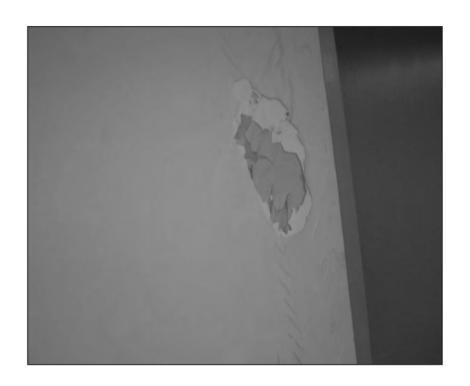
Plaster Wall Sample 448

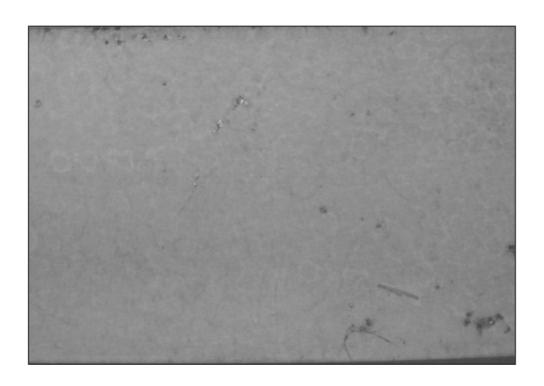
Metal Wall Sample 546

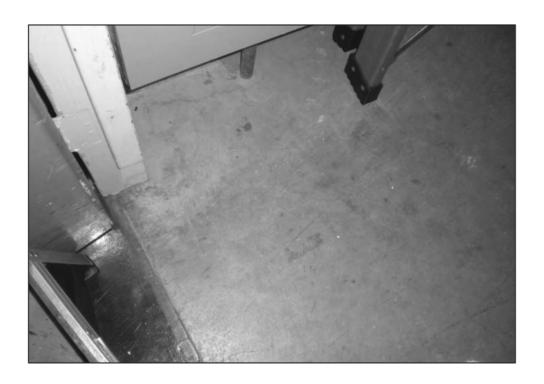
Concrete Floor Sample 751

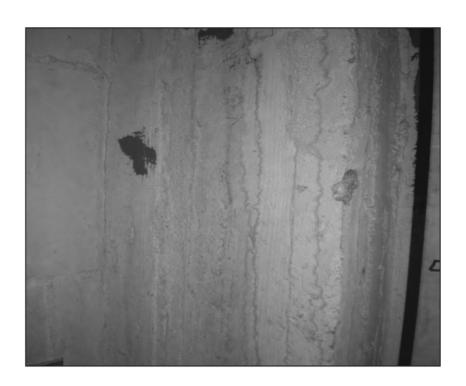
Concrete Wall Sample 1051

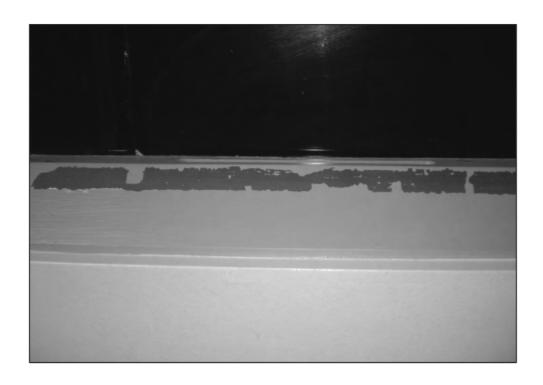
Metal Window Casing Sample 1091

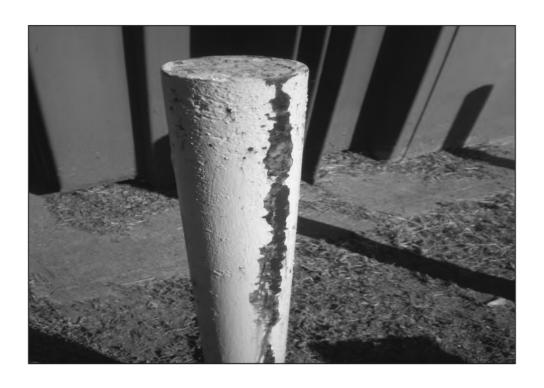
Metal Bollard Exterior Sample 1940

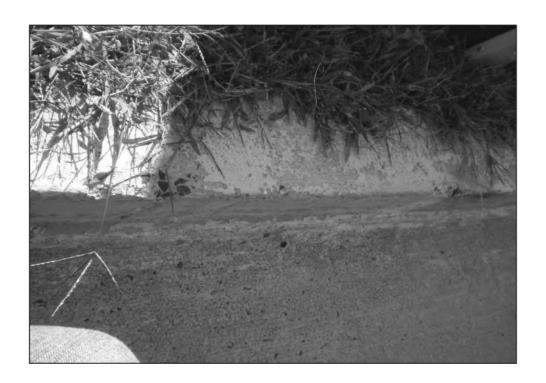
Concrete Curb Exterior Sample1955

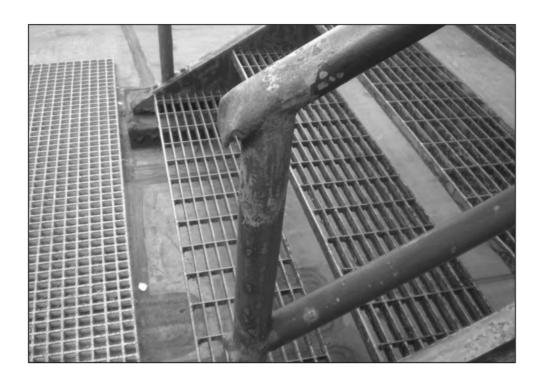
Metal Stair Handrail Exterior Sample 1977

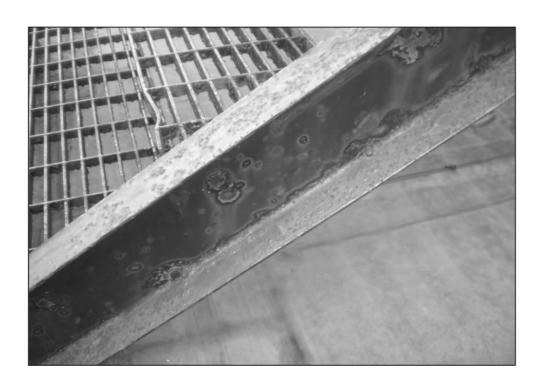
Metal Stair Stringer Exterior Sample 1978

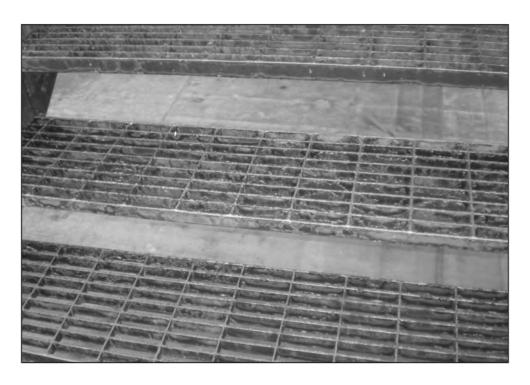
Metal Stair Tread Exterior Sample 1979
