**VOLUME II
ASBESTOS CONTAINING MATERIAL &
LEAD CONTAINING PAINT
SURVEY REPORT
BUILDING 1**

VISN 1
West Haven VA Medical Center
950 Campbell Avenue
West Haven, Connecticut

Project No. 2009023.006

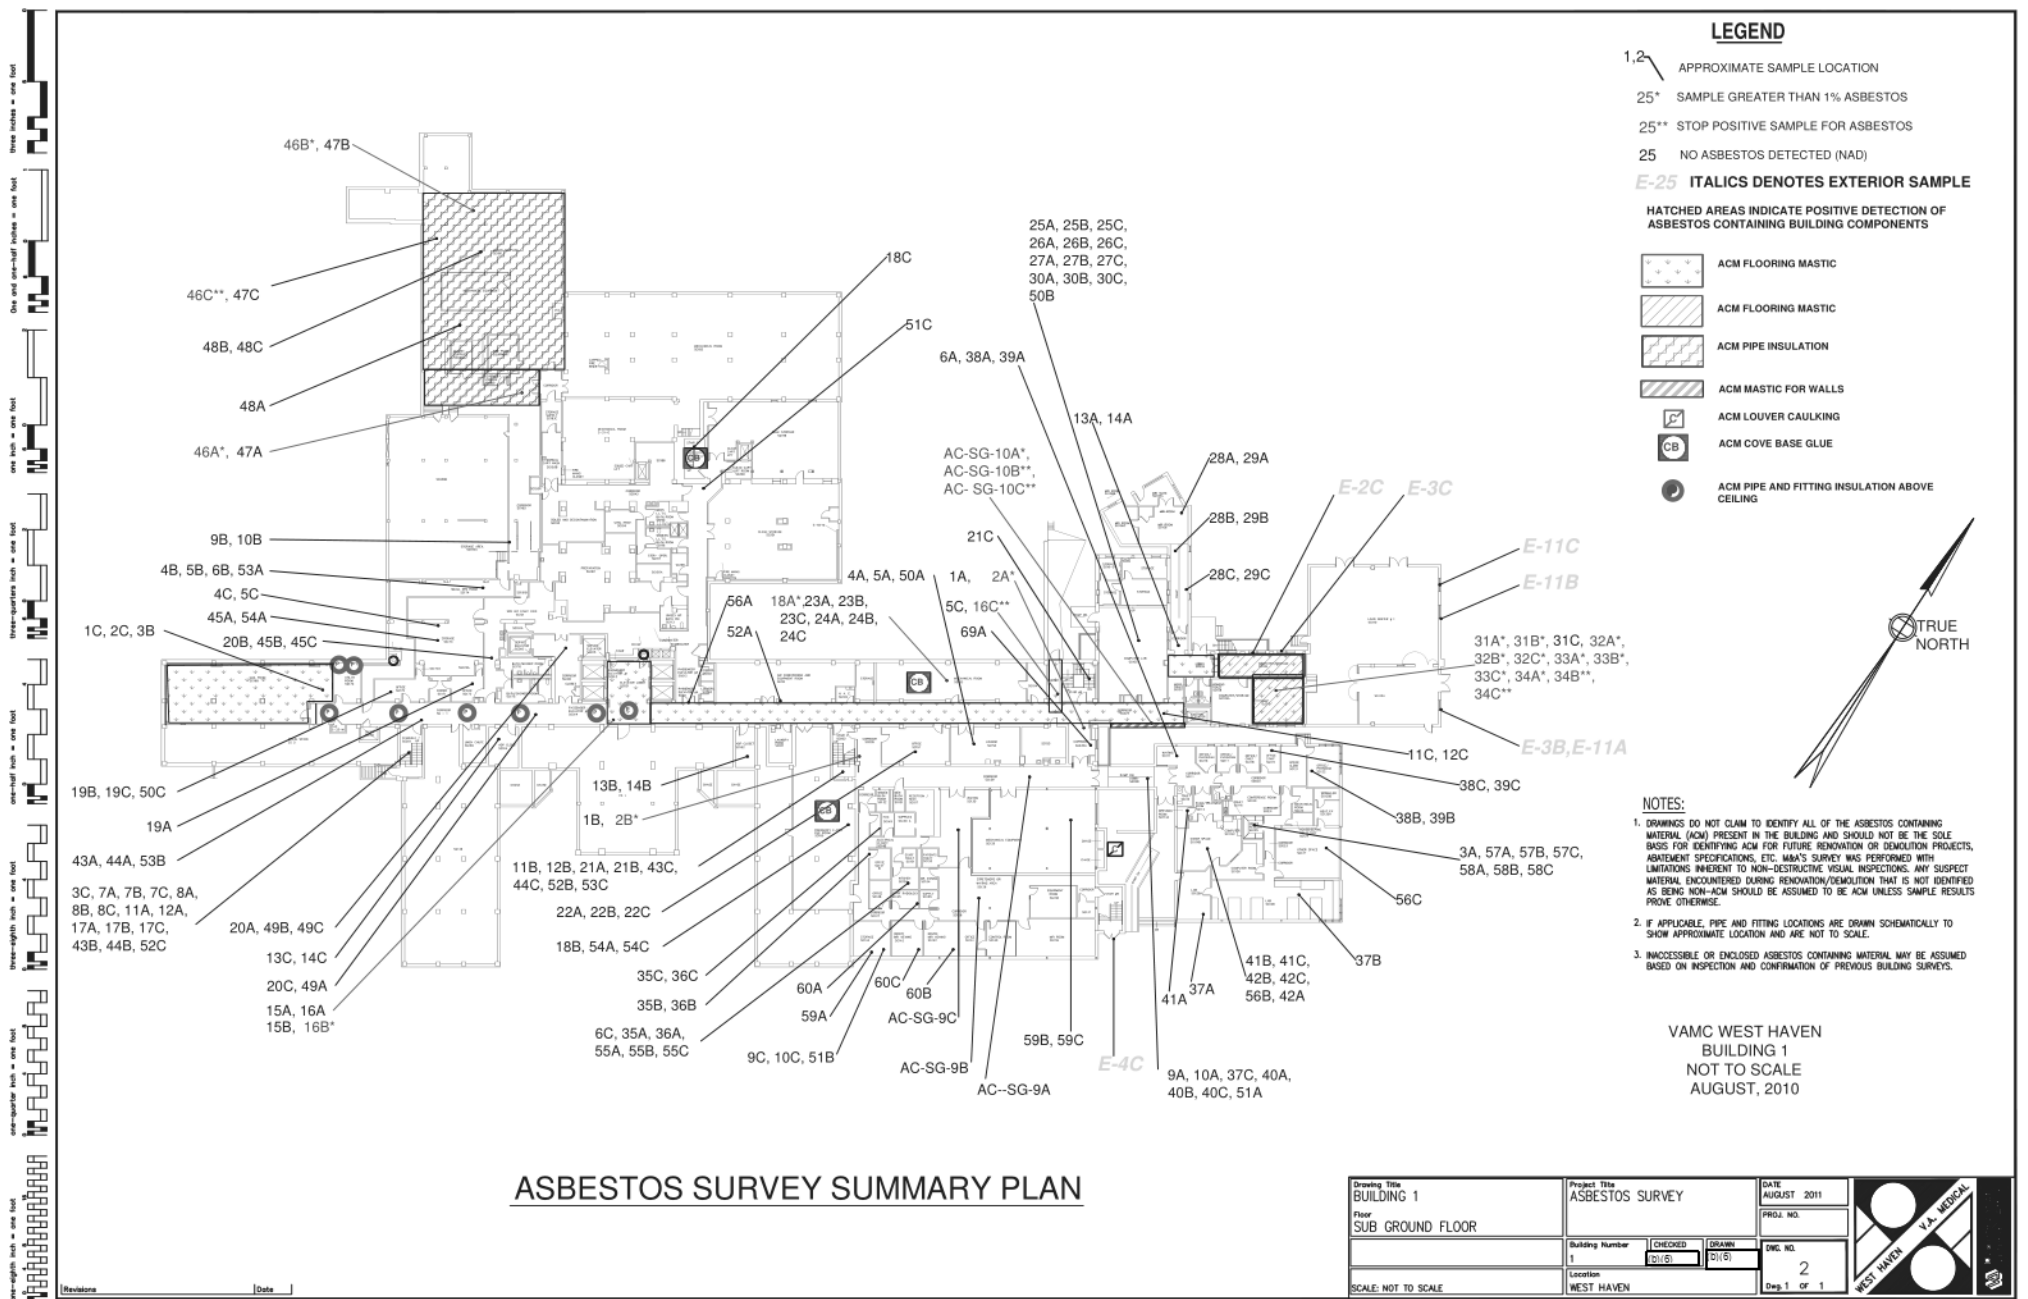
Drawing Title BUILDING 1		Project Title ASBESTOS SURVEY		DATE AUGUST 2011
Floor SUB GROUND FLOOR		Building Number 1		PRJ# NO.
Location WEST HAVEN		Checked SIL/ES	Drawn D/GB	DWG. NO. 2
SCALE: NOT TO SCALE		Location WEST HAVEN		Dep. 1 OF 1

- 1,2 \ APPROXIMATE SAMPLE LOCATION
- 25* SAMPLE GREATER THAN 1% ASBESTOS
- 25** STOP POSITIVE SAMPLE FOR ASBESTOS
- 25 NO ASBESTOS DETECTED (NAD)
- E-25* ITALICS DENOTES EXTERIOR SAMPLE

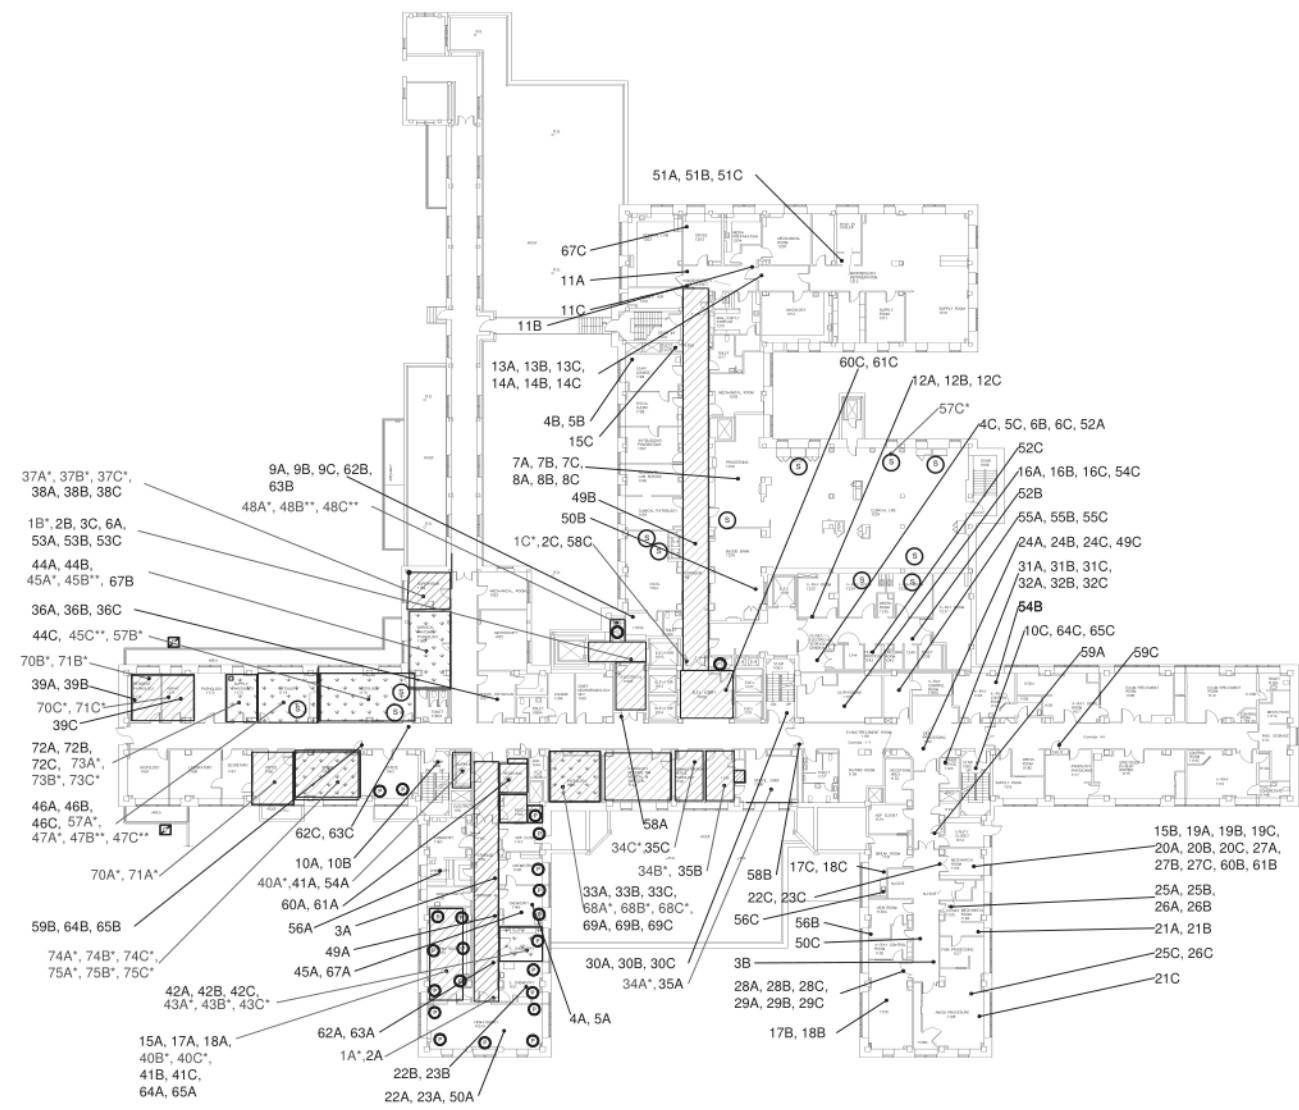
Drawing Title BUILDING 1 Floor FIRST FLOOR	Project Title ASBESTOS SURVEY	DATE AUGUST 2011	
	Building Number 1	Checked (S)(S) (D)(S)	
Location WEST HAVEN	DWG. NO. 4	Dep. 1 of 1	
SCALE: NOT TO SCALE

- LEGEND**
- 1,2 APPROXIMATE SAMPLE LOCATION
 - 25* SAMPLE GREATER THAN 1% ASBESTOS
 - 25** STOP POSITIVE SAMPLE FOR ASBESTOS
 - 25 NO ASBESTOS DETECTED (NAD)

- HATCHED AREAS INDICATE POSITIVE DETECTION OF ASBESTOS CONTAINING BUILDING COMPONENTS
- ACM VINYL FLOOR TILE
 - ACM FLOORING MASTIC
 - ACM PIPE CHASE INSULATION
 - ACM SINK UNDERCOATING
 - ACM LOUVER CAULKING
 - ACM PIPE AND FITTING INSULATION ABOVE CEILING

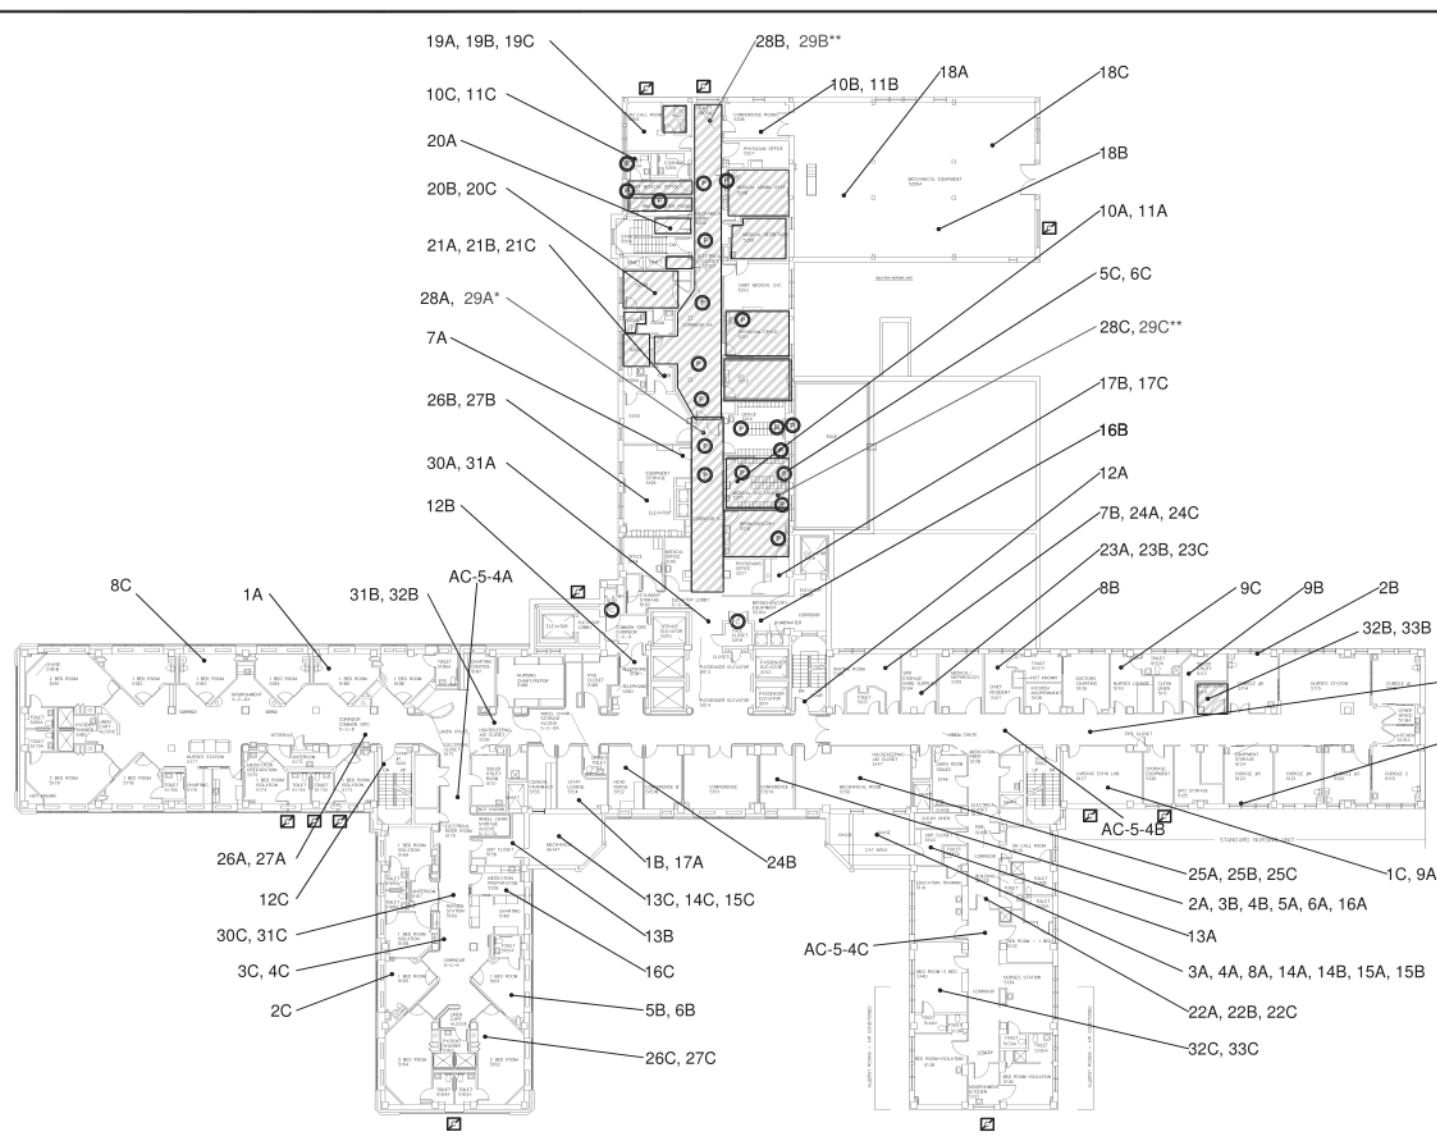
Drawing Title BUILDING 1 Floor FIFTH FLOOR	Project Title ASBESTOS SURVEY		DATE AUGUST 2011
	Building Number 1		PROJ. NO.
Location WEST HAVEN	CHECKED [Signature]	DATE [Date]	DWG. NO. 8
SCALE: NOT TO SCALE	Location WEST HAVEN		Dep 1 of 1

- LEGEND**
- 1,2 APPROXIMATE SAMPLE LOCATION
 - 25* SAMPLE GREATER THAN 1% ASBESTOS
 - 25** STOP POSITIVE SAMPLE FOR ASBESTOS
 - 25 NO ASBESTOS DETECTED (NAD)
- HATCHED AREAS INDICATE POSITIVE DETECTION OF ASBESTOS CONTAINING BUILDING COMPONENTS
- [Hatched Box] ACM FLOORING MASTIC
 - [Square with X] ACM LOUVER CAULKING
 - [Circle with X] ACM PIPE CHASE INSULATION
 - [Circle with O] ACM PIPE AND FITTING INSULATION ABOVE CEILING

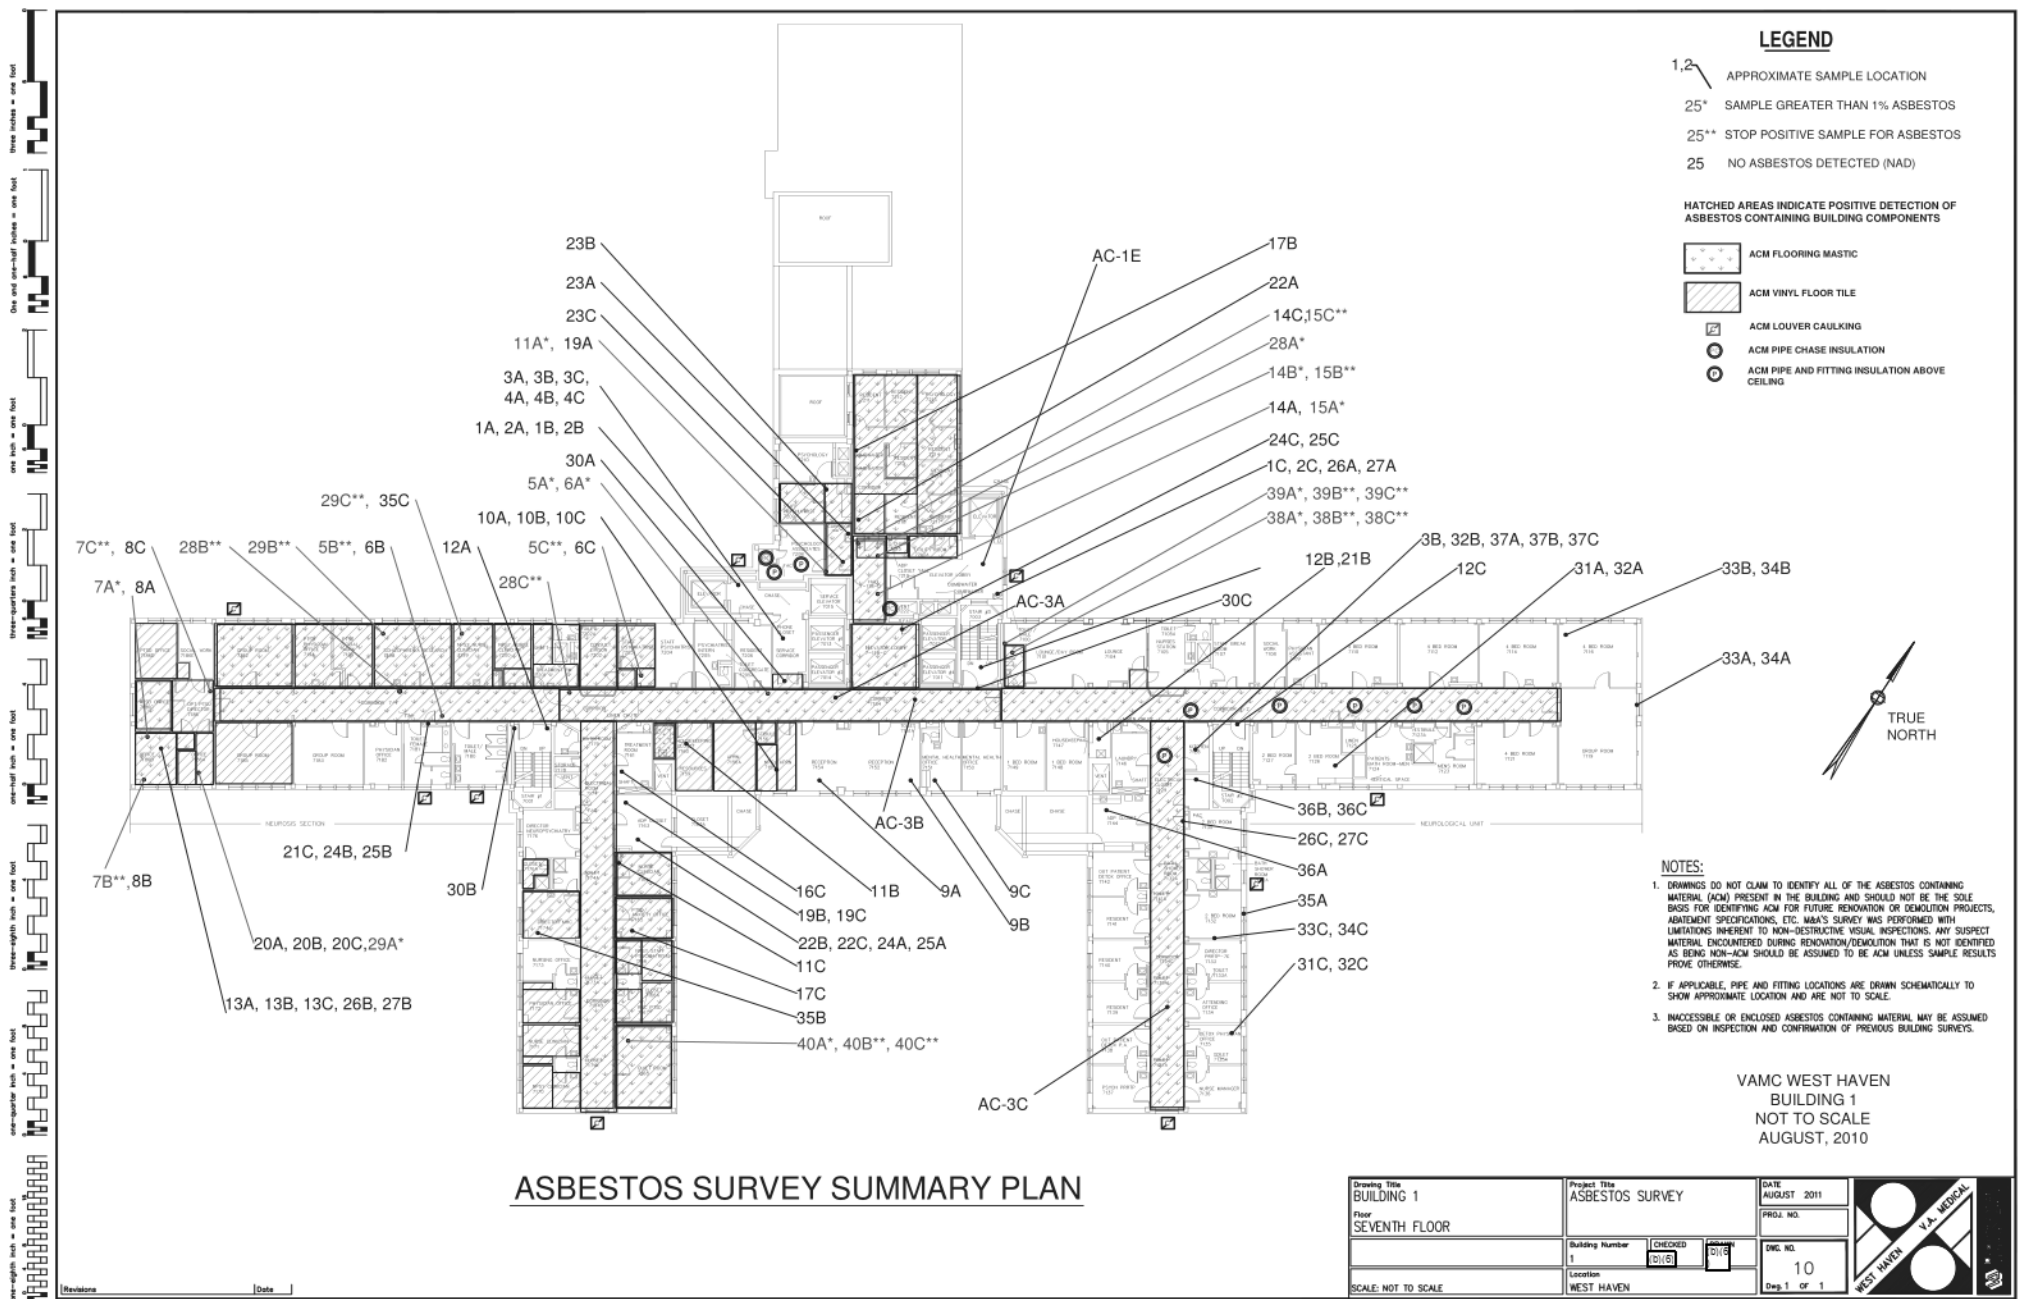
Drawing Title BUILDING 1 Floor SEVENTH FLOOR	Project Title ASBESTOS SURVEY	DATE AUGUST 2011	
Building Number 1	Checked [Signature]	DWG. NO. 10	
Location WEST HAVEN	Scale NOT TO SCALE	Dep. 1 OF 1

ASBESTOS SURVEY SUMMARY PLAN

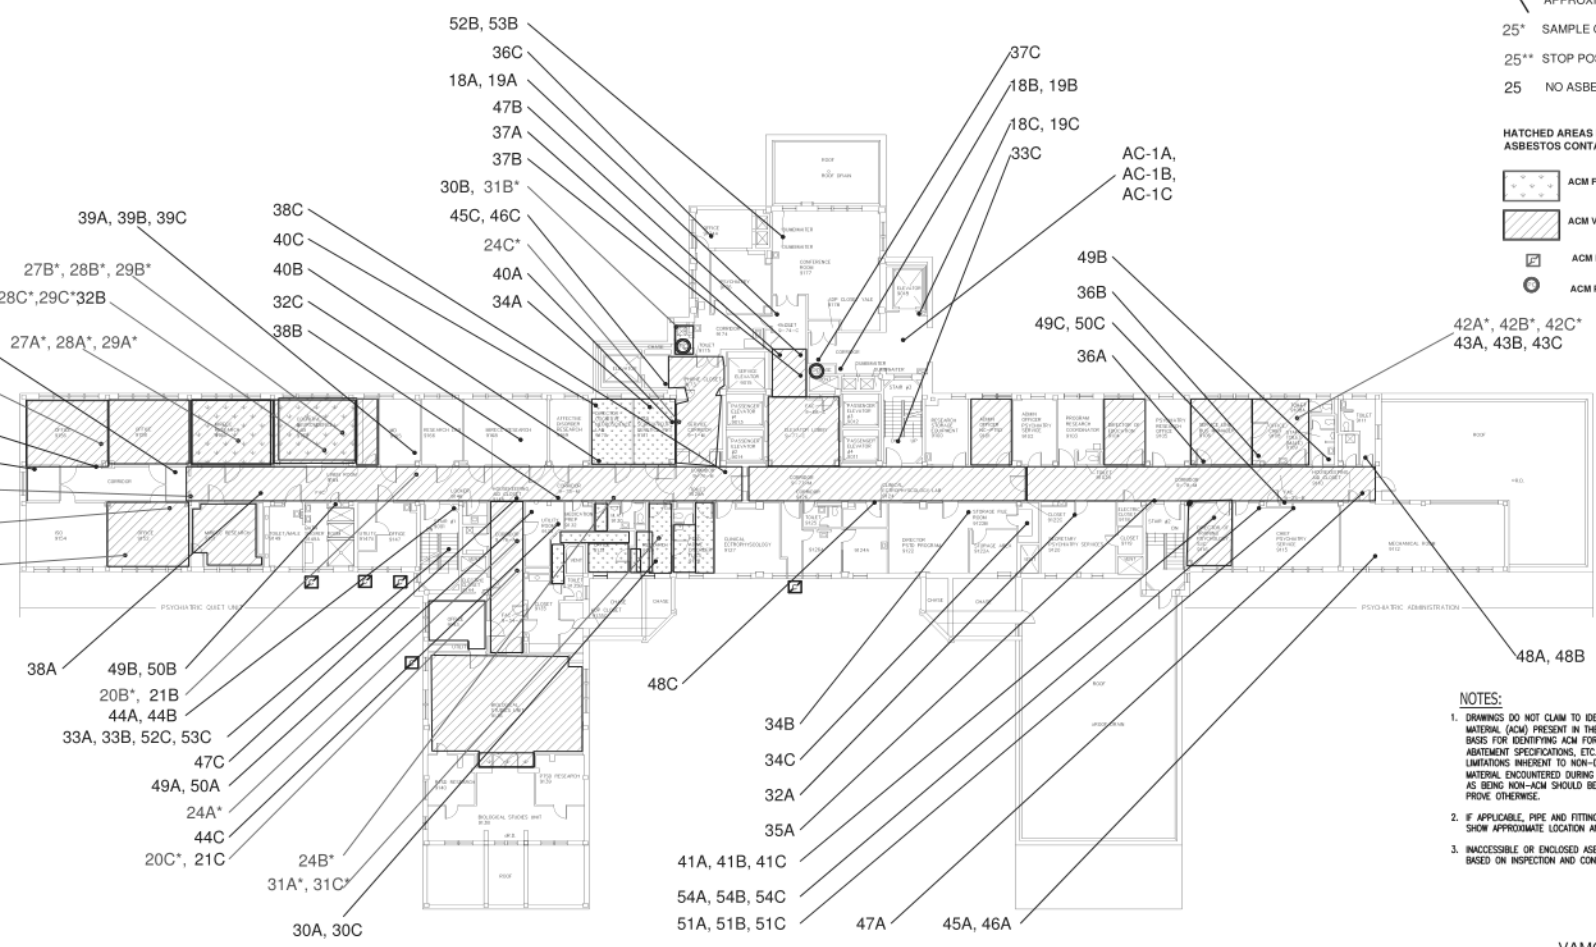
Drawing Title BUILDING 1 Floor NINTH FLOOR	Project Title ASBESTOS SURVEY	DATE AUGUST 2011	
Building Number 1	Checked (S)/(S)	Drawn (S)/(S)	
Location WEST HAVEN	DWG. NO. 12 Dep. 1 OF 1		
SCALE: NOT TO SCALE

ASBESTOS SURVEY SUMMARY PLAN

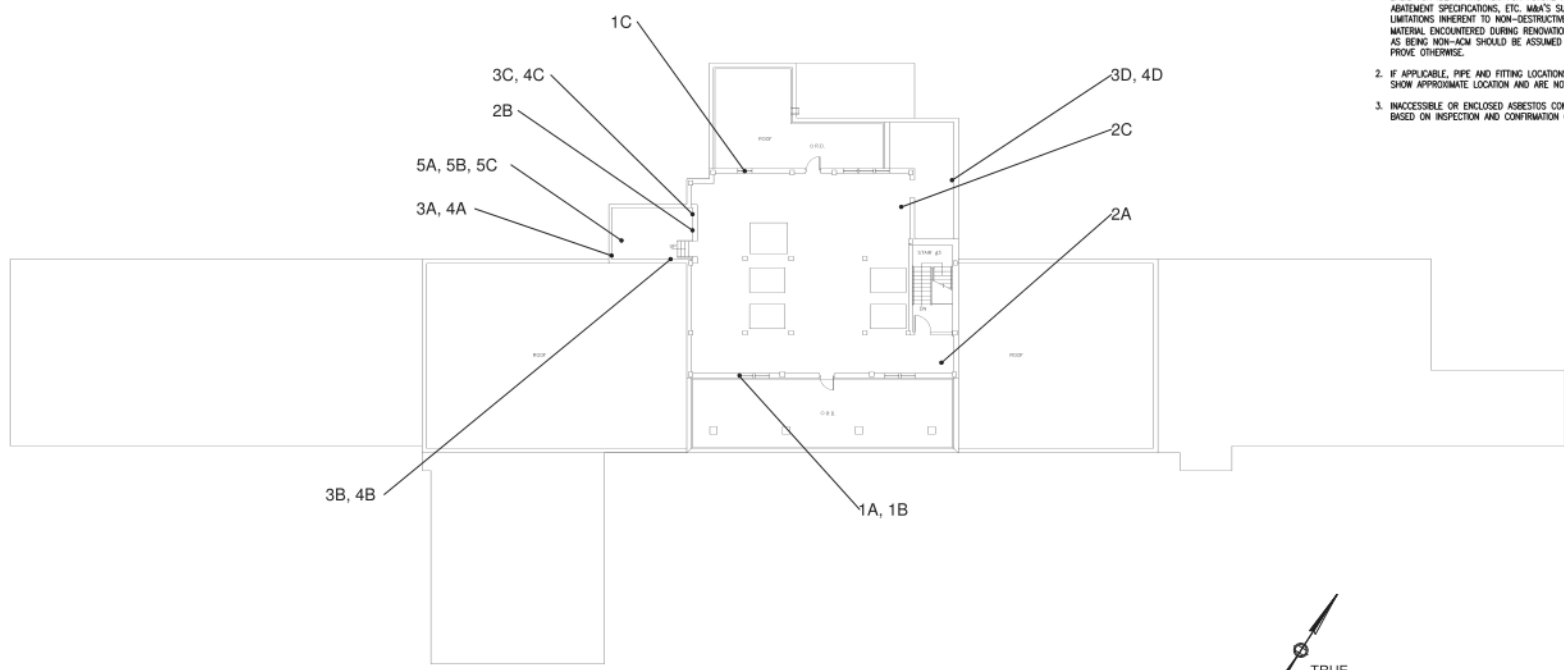
Drawing Title BUILDING 1		Project Title ASBESTOS SURVEY		DATE AUGUST 2011
Floor ELEVENTH FLOOR - PENTHOUSE		Building Number 1		PRIO. NO.
Location WEST HAVEN		(b)(6)	(b)(6)	DWG. NO. 14
SCALE: NOT TO SCALE		WEST HAVEN V.A. MEDICAL		Dep. 1 OF 1

- LEGEND**
- 1,2 APPROXIMATE SAMPLE LOCATION
 - 25* SAMPLE GREATER THAN 1% ASBESTOS
 - 25** STOP POSITIVE SAMPLE FOR ASBESTOS
 - 25 NO ASBESTOS DETECTED (NAD)

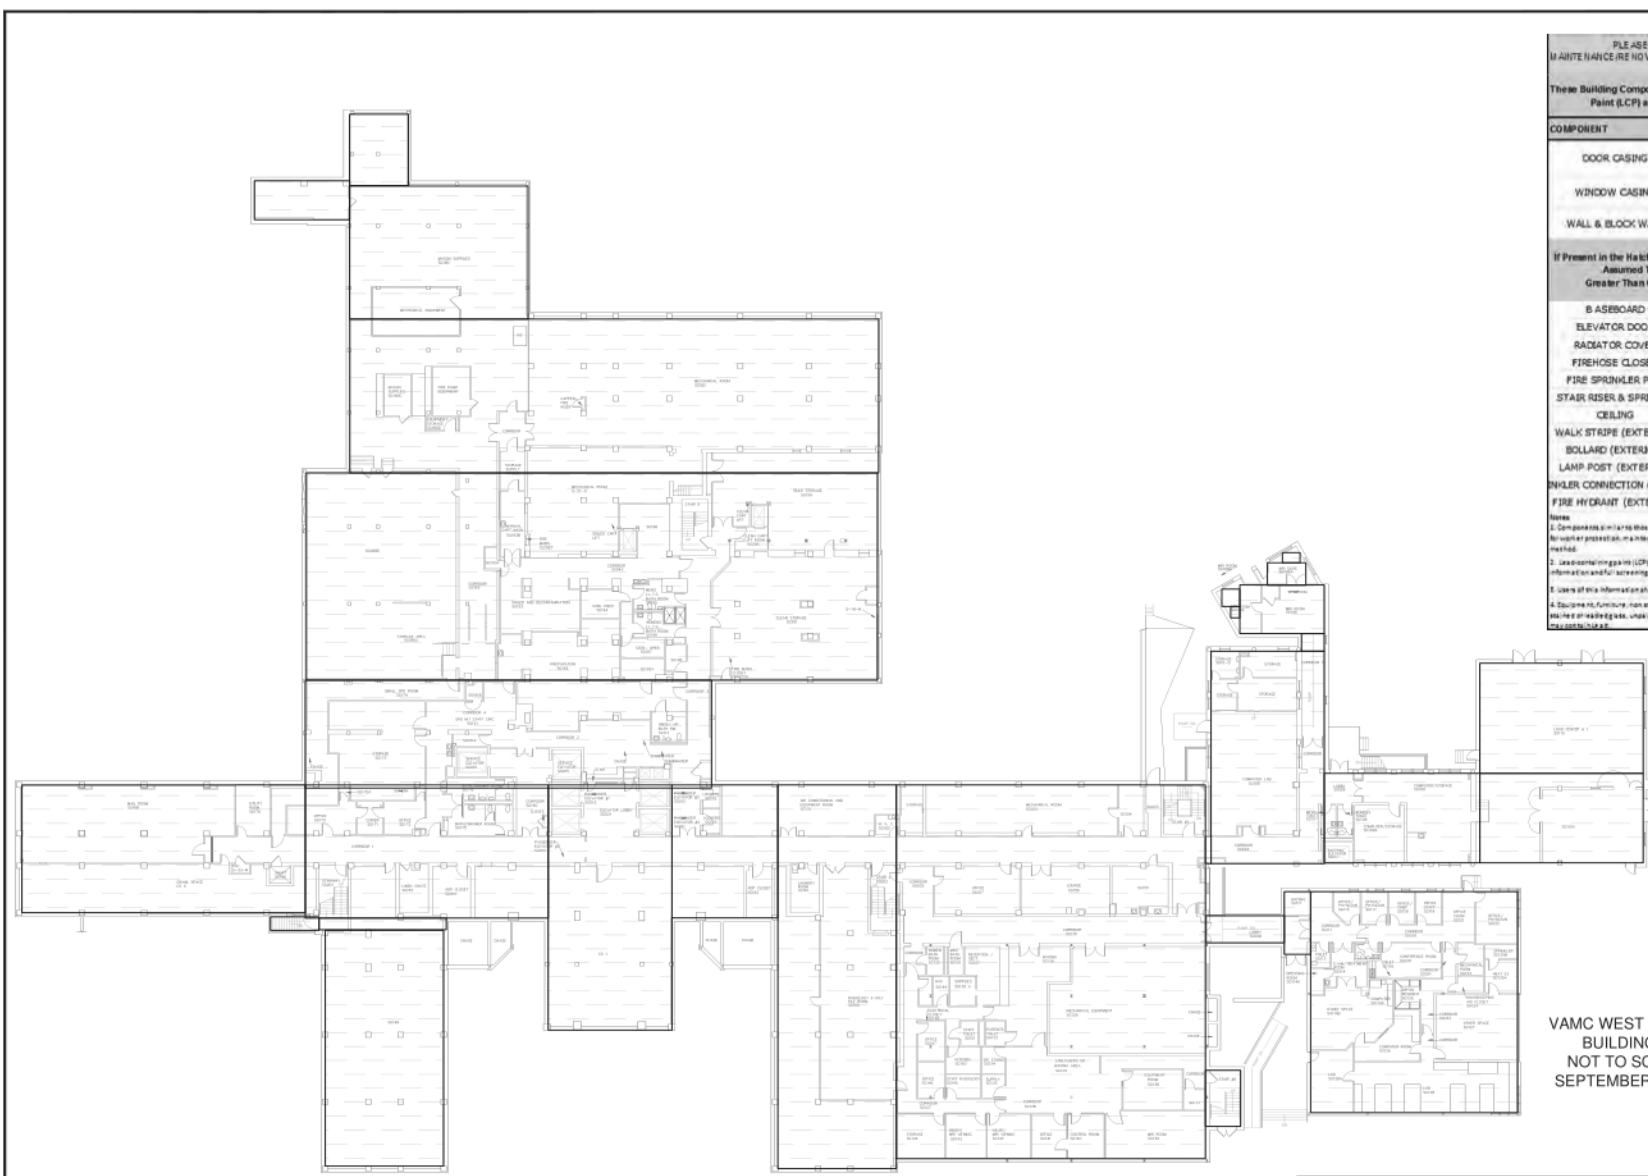
Drawing Title BUILDING 1 Floor SUB GROUND FLOOR	Project Title LEAD SURVEY	DATE AUGUST 2011	
Building Number 1	CHECKED (D)(S)	DRAWN (S)(S)	
Location WEST HAVEN	DWG. NO. 16	Dep. 1 OF 1	
SCALE: NOT TO SCALE

PLEASE SEE THE SAFETY OFFICE PRIOR TO PERFORMING MAINTENANCE/RENOVATION ACTIVITIES ON ANY OF THE FOLLOWING COMPONENTS IN HATCHED AREAS

These Building Components Depicted in Red Are Assumed to Contain Lead Containing Paint (LCP) at Greater Than 0.1 mg/cm² unless otherwise determined.

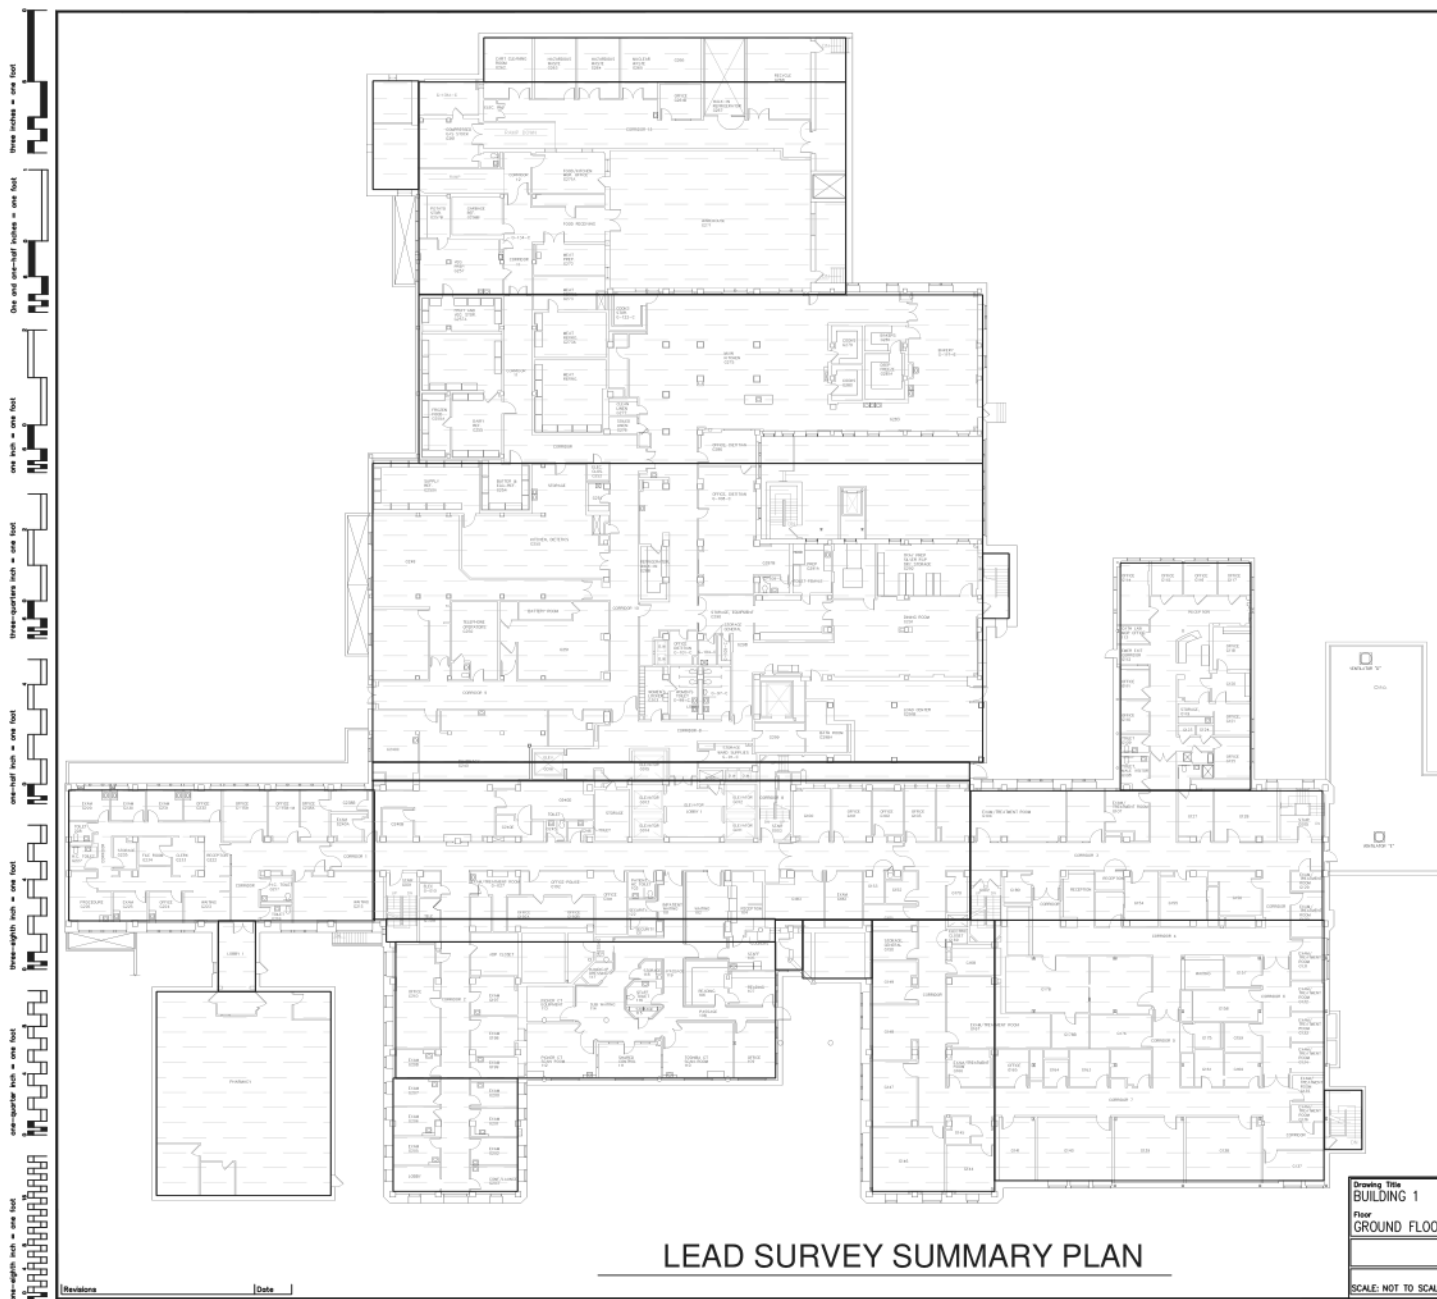
Drawing Title BUILDING 1 Floor GROUND FLOOR	Project Title LEAD SURVEY	DATE AUGUST 2011	
	Subbing Number 1	PROJ. NO.	
	Location WEST HAVEN	DWG. NO. 17	
SCALE: NOT TO SCALE		Dep. 1 OF 1

PLEASE SEE THE SAFETY OFFICE PRIOR TO PERFORMING MAINTENANCE/RENOVATION ACTIVITIES ON ANY OF THE FOLLOWING COMPONENTS IN HATCHED AREAS.

These Building Components Depicted in Red Are Assumed To Contain Lead Containing Paint (LCP) at Greater Than 0.1 mg/cm² unless otherwise determined.

- Components similar to those listed in the table above found in the hatched areas should be assumed to contain LCP for worker protection, maintenance, renovation, disposal, etc. purposes unless otherwise determined by an approved method.
- Lead-containing paint (LCP) screening measurements were collected using an XRF analyzer. For additional information and full screening results refer to the M&A Asbestos & LCP Building Report.
- Users of this information should not rely on color alone to decide whether similar building components contain LCP.
- Equipment, furniture, non-structural items, and non-painted building components such as glazed tile, glazed block, stained or leaded glass, unpainted piping, etc. were not included in the survey and are not included in the table but may contain Lead.

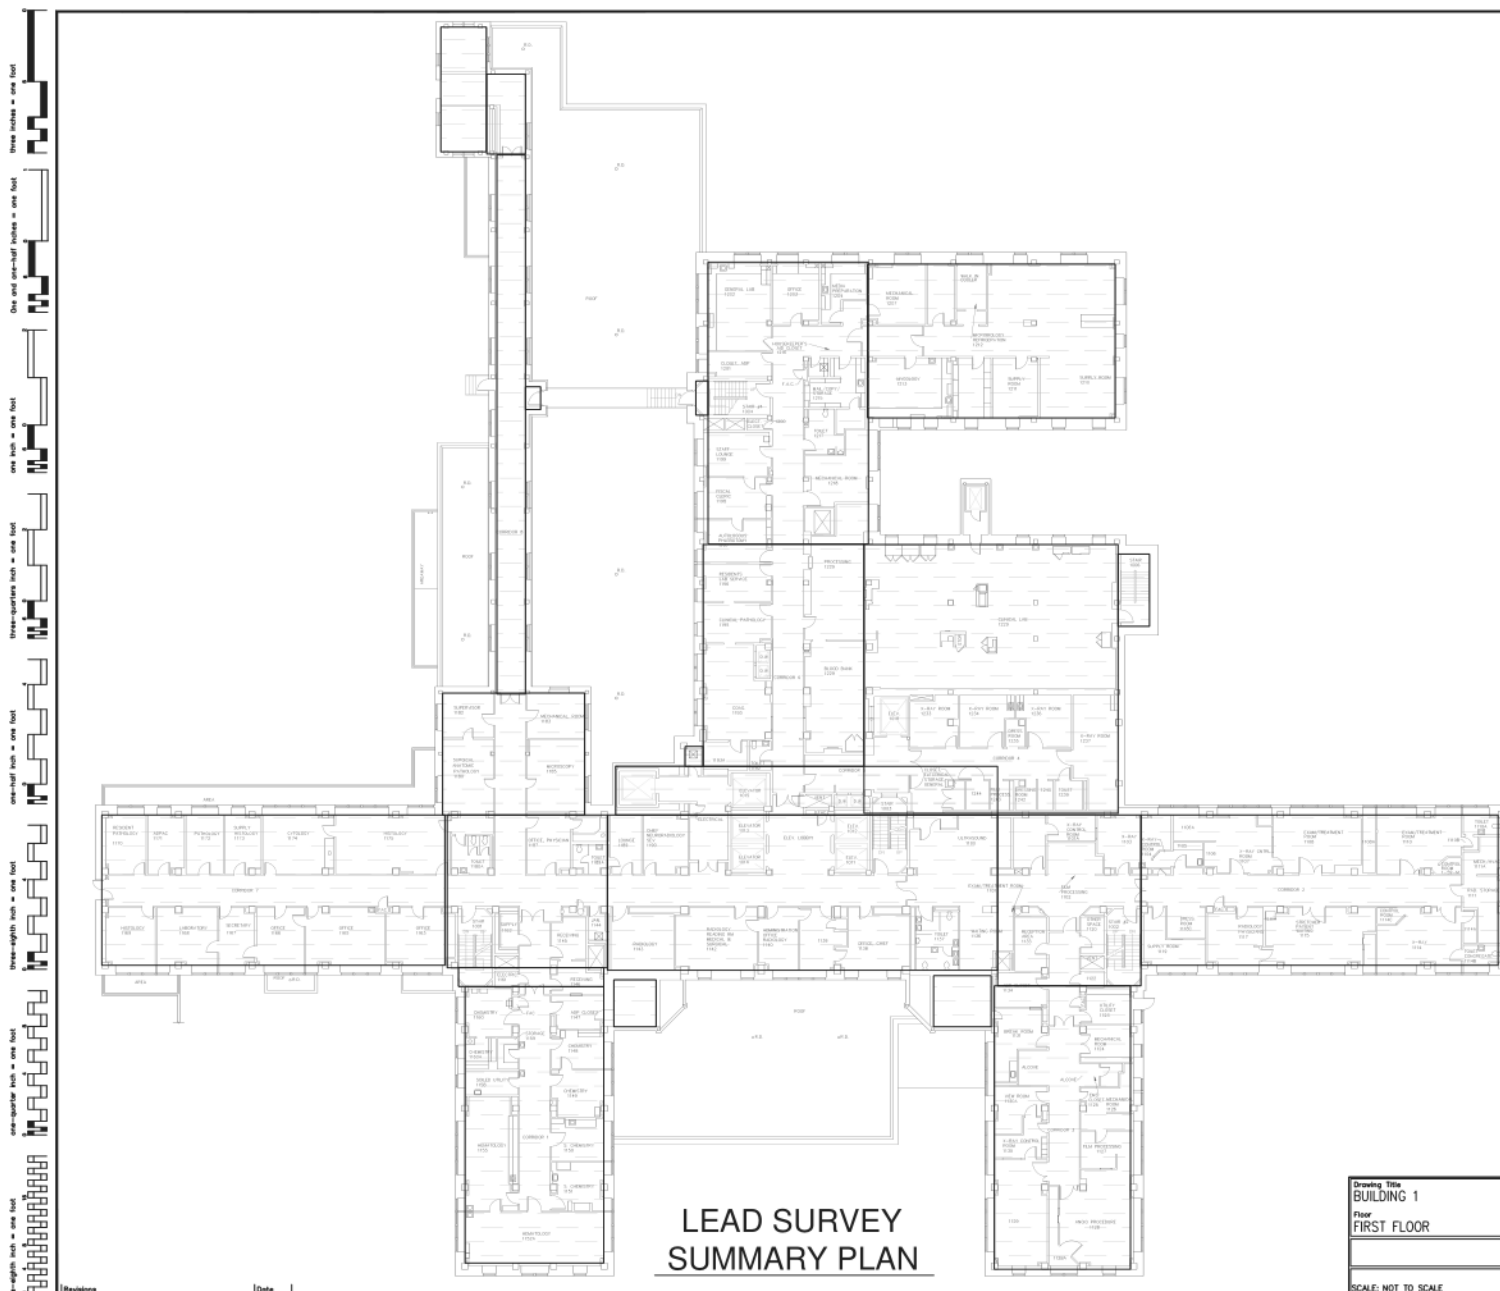
Drawing Title BUILDING 1 Floor FIRST FLOOR	Project Title LEAD SURVEY	DATE AUGUST 2011	
	Building Number 1	PROJ. NO.	
	Location WEST HAVEN	DWG. NO. 18 Dep. 1 of 1	
SCALE: NOT TO SCALE

LEAD SURVEY SUMMARY PLAN

PLEASE SEE THE SAFETY OFFICE PRIOR TO PERFORMING MAINTENANCE/RENOVATION ACTIVITIES ON ANY OF THE FOLLOWING COMPONENTS IN HATCHED AREAS

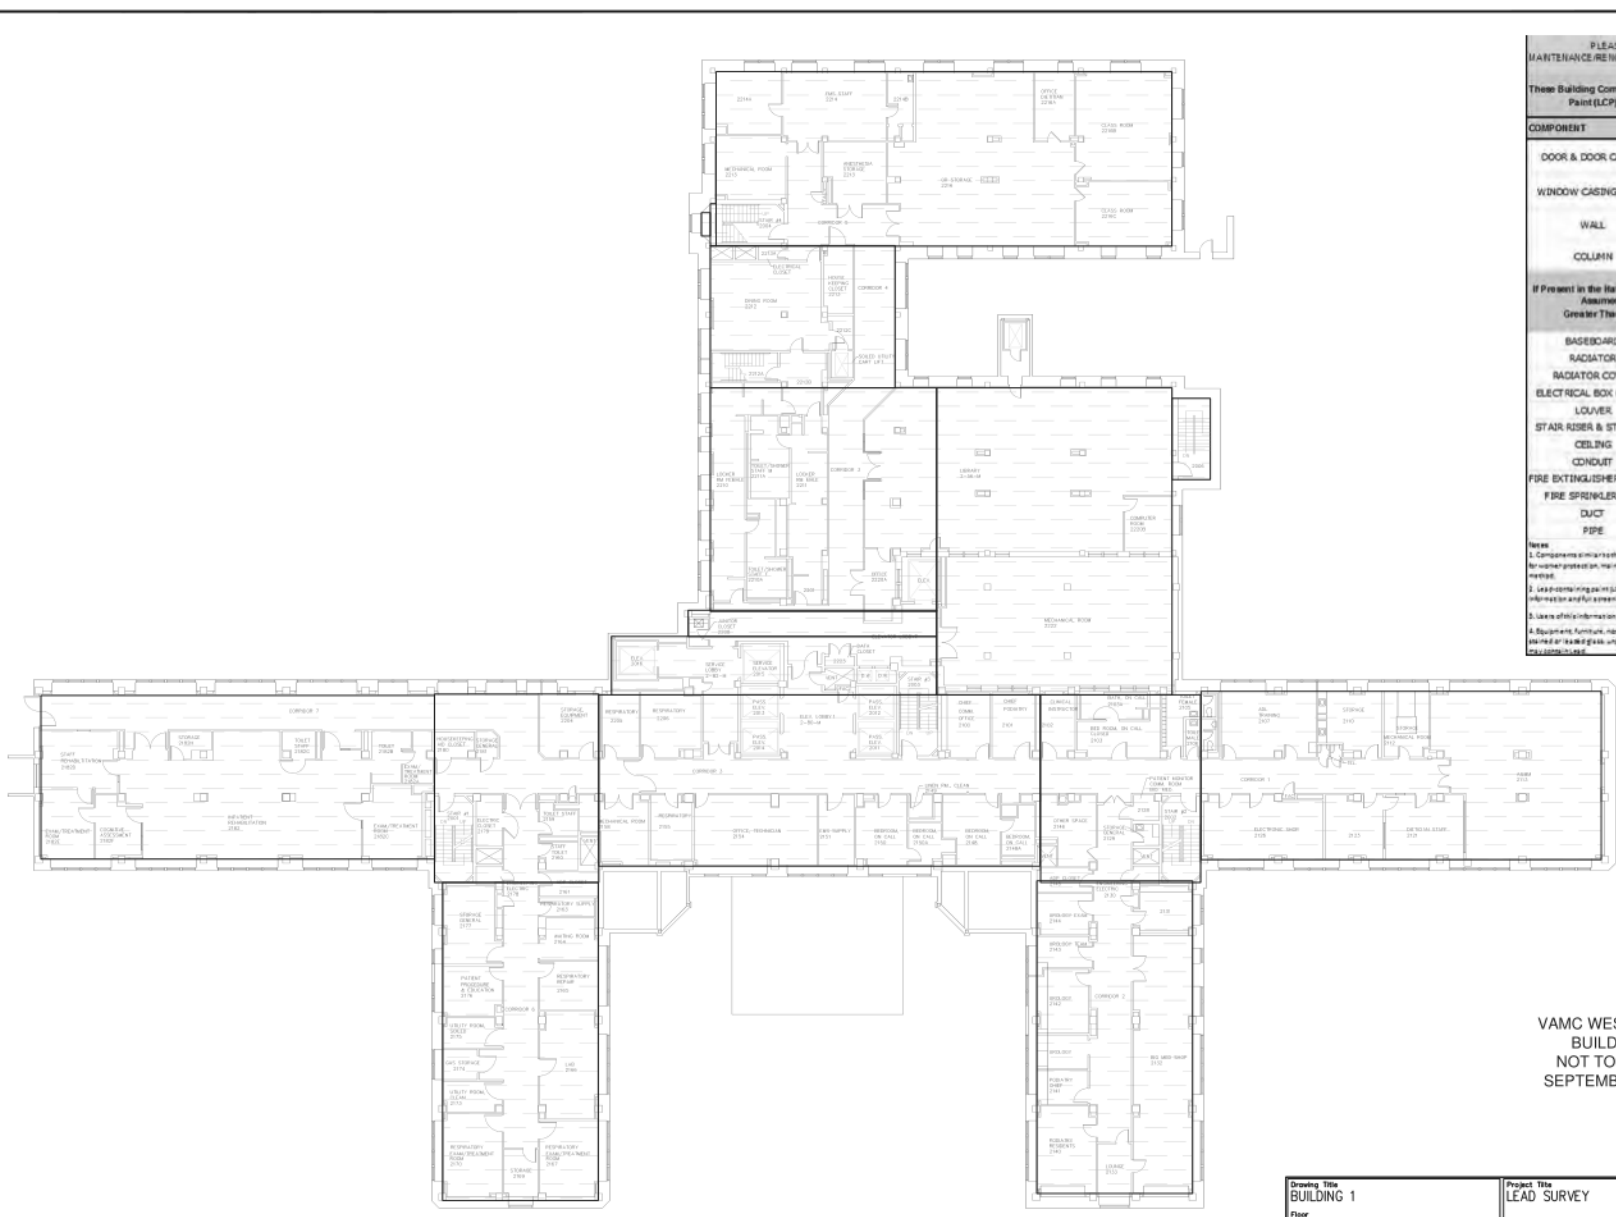
Drawing Title BUILDING 1 Floor SECOND FLOOR	Project Title LEAD SURVEY	DATE AUGUST 2011	
Subbing Number 1	Drawings 01/05	Drawings 02/05	
Location WEST HAVEN	Page No. 19	Dep. 1 of 1	
SCALE: NOT TO SCALE

PLEASE SEE THE SAFETY OFFICE PRIOR TO PERFORMING MAINTENANCE/RENOVATION ACTIVITIES ON ANY OF THE FOLLOWING COMPONENTS IN HATCHED AREAS

These Building Components Depicted in Red Are Assumed To Contain Lead Containing Paint (LCP) at Greater Than 0.1 mg/m² unless otherwise determined.

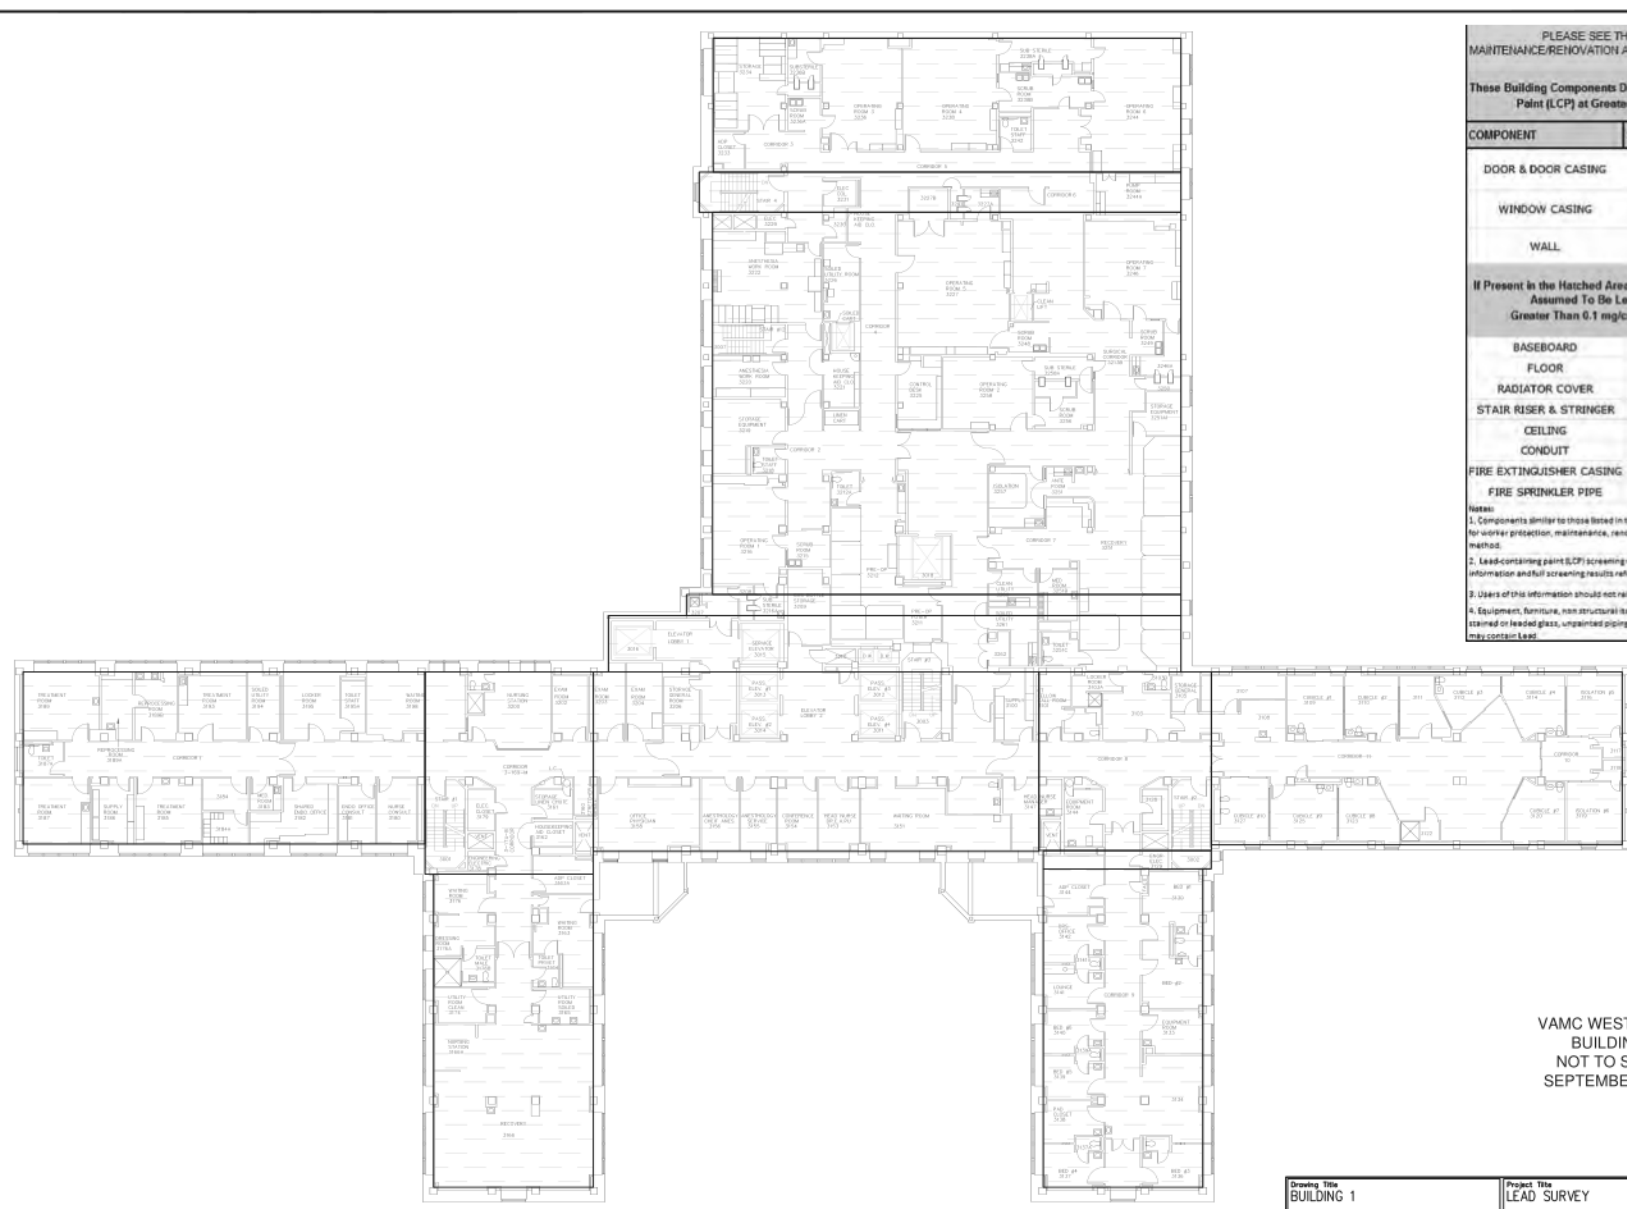
Drawing Title BUILDING 1 Floor THIRD FLOOR	Project Title LEAD SURVEY	DATE AUGUST 2011	
Subbing Number 1	<input checked="" type="checkbox"/> DIV 6 <input type="checkbox"/> DIV 5	PROJ. NO.	
Location WEST HAVEN	SCALE: NOT TO SCALE	DWG. NO. 20 Dep. 1 of 1

PLEASE SEE THE SAFETY OFFICE PRIOR TO PERFORMING MAINTENANCE/RENOVATION ACTIVITIES ON ANY OF THE FOLLOWING COMPONENTS IN HATCHED AREAS
 These Building Components Depicted in Hatched Areas Assumed To Contain Lead Containing Paint (LCP) at Greater Than 0.1 mg/cm² unless otherwise determined.

COMPONENT	SUBSTRATE	SYMBOL
DOOR & DOOR CASING	METAL	[Symbol]
WINDOW CASING	METAL	[Symbol]
WALL	PLASTER, WALLBOARD	[Symbol]
If Present in the Hatched Area These Other Building Components Are Assumed To Be Lead Containing Paint (LCP) at Greater Than 0.1 mg/cm ² unless otherwise determined.		SYMBOL
BASEBOARD	METAL	[Symbol]
FLOOR	METAL	[Symbol]
RADIATOR COVER	METAL	[Symbol]
STAIR RISER & STRINGER	METAL	[Symbol]
CEILING	PLASTER	[Symbol]
CONDUIT	METAL	[Symbol]
FIRE EXTINGUISHER CASING	METAL	[Symbol]
FIRE SPRINKLER PIPE	METAL	[Symbol]
