**VOLUME II
ASBESTOS CONTAINING MATERIAL &
LEAD CONTAINING PAINT
SURVEY REPORT
BUILDING 1**

VISN 1
West Haven VA Medical Center
950 Campbell Avenue
West Haven, Connecticut

Project No. 2009023.006

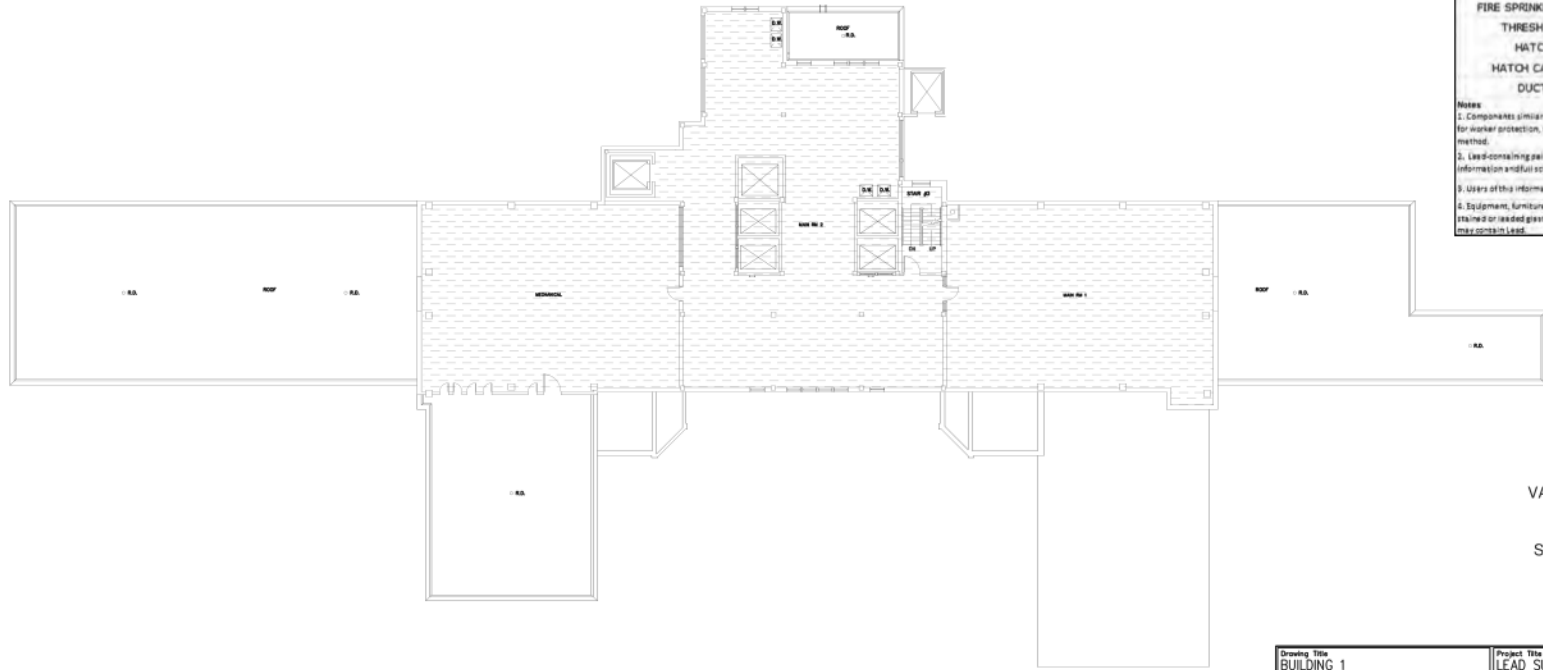
Drawing Title BUILDING 1 Floor NINTH FLOOR	Project Title LEAD SURVEY	DATE AUGUST 2011	
Building Number 1	Checked DI(S)	Drawn DI(S)	
Location WEST HAVEN	DWG. NO. 26	Dep. 1 of 1	
SCALE: NOT TO SCALE

PLEASE SEE THE SAFETY OFFICE PRIOR TO PERFORMING MAINTENANCE/RENOVATION ACTIVITIES ON ANY OF THE FOLLOWING COMPONENTS IN HATCHED AREAS

These Building Components Depicted in Red Are Assumed To Contain Lead Containing Paint (LCP) at Greater Than 0.1 mg/cm² unless otherwise determined.

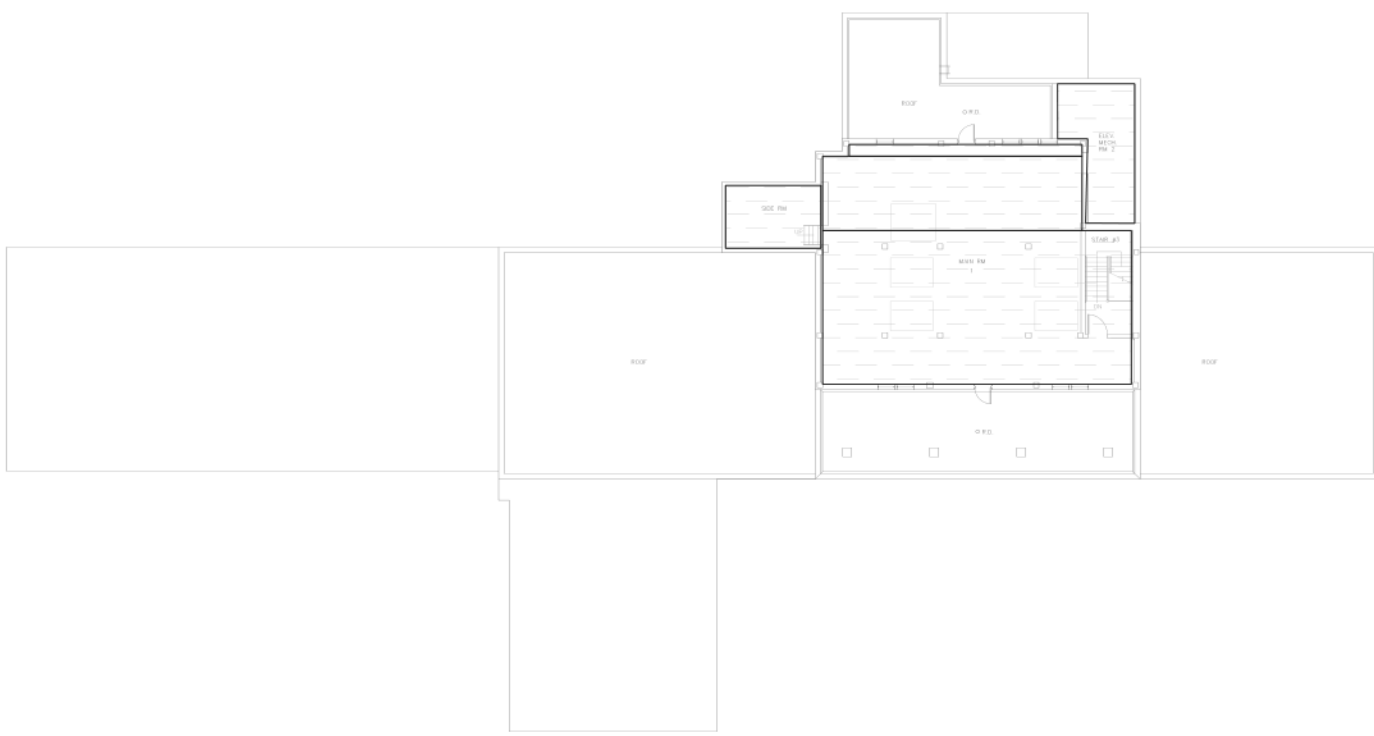
PLEASE SEE THE SAFETY OFFICE PRIOR TO PERFORMING MAINTENANCE/RENOVATION ACTIVITIES ON ANY OF THE FOLLOWING COMPONENTS IN HATCHED AREAS

These Building Components Depicted in Red Are Assumed To Contain Lead Containing Paint (LCP) at Greater Than 0.1 mg/cm² unless otherwise determined.
