Table 5 - Summary of XRF Measurement	S
West Haven VA Medical Center, Building	1

Appendix C

Representative Photographs of ACM

Representative Photographs of Non-Intact Lead Containing Paint Greater than or Equal to 1.0 mg/cm

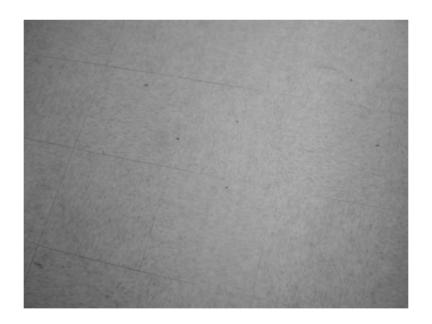
Glue w/12"x12" Cream Vinyl Floor Tile w/Gray Streaks Sample SSG – 18A

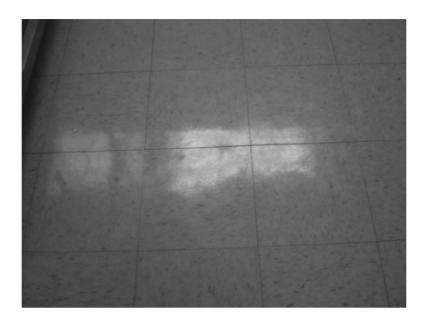
Mastic w/12"x12" Cream Vinyl Floor Tile w/Tan Specks Sample SG - 2A

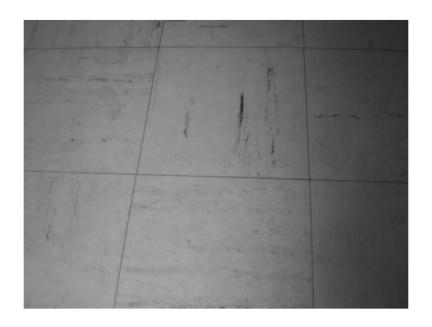
Glue for 12"x12" Cream Floor Tile Sample G - 33A

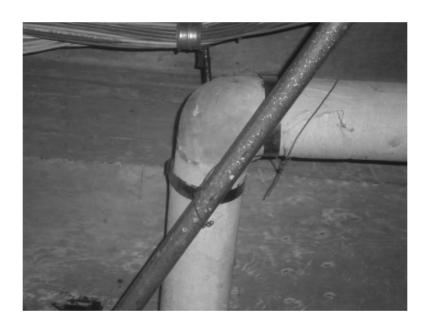
Pipe Insulation Sample G - 63A

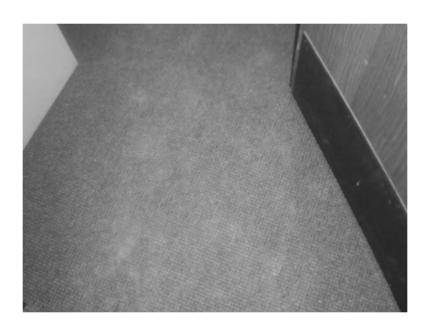
12"x12" Gray Vinyl Floor Tile w/Gray Specks (below carpet) Sample 1 - 68A

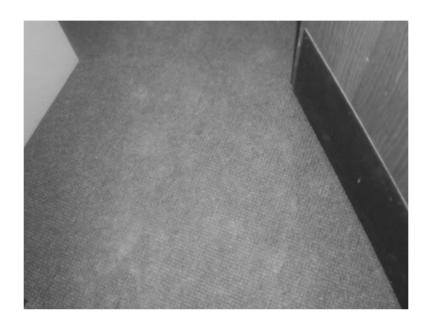
9"x9" Black Vinyl Floor Tile (below carpet) Sample 1 - 70A

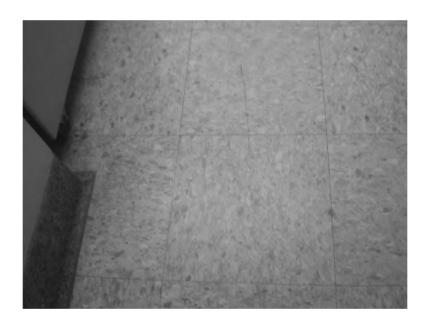
Mastic w/12"x12" Light Brown Vinyl Floor Tile w/Dark Brown Specks Sample 1 - 73A

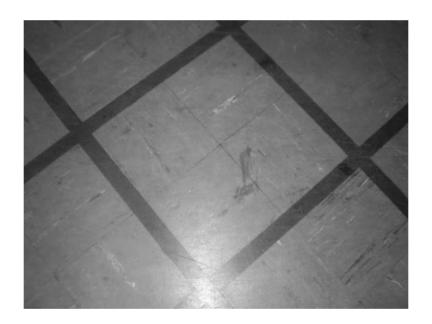
Mastic w/12"x12" Tan Vinyl Floor Tile Stone Pattern Sample 1 - 75A

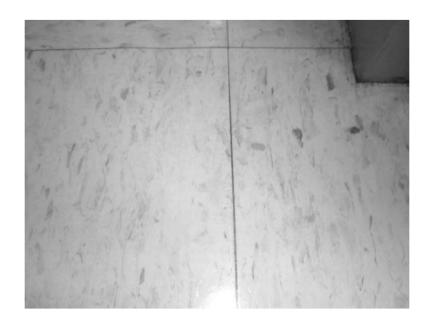
Mastic w/9"x9" Light Green Vinyl Floor Tile w/Gray Specks Sample 4 - 7A

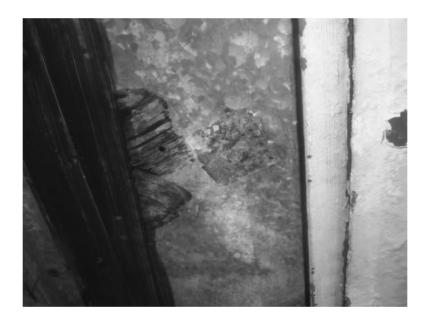
Sink Undercoating Black Sample 6 - 11A

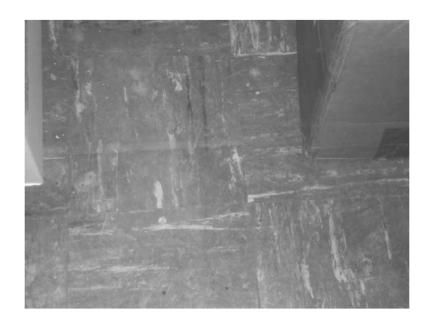
Mastic w/9"x9" Dark Brown Vinyl Floor Tile w/White Streaks (below carpet)
Sample 6 - 27A

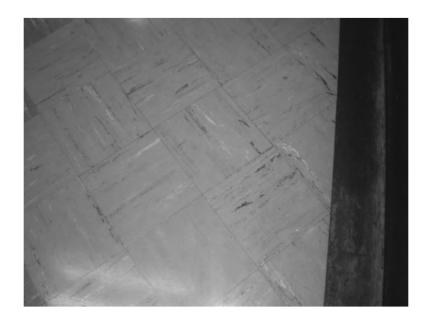
9"x9" Light Brown Vinyl Floor Tile w/Black Streaks Sample 7 - 5A

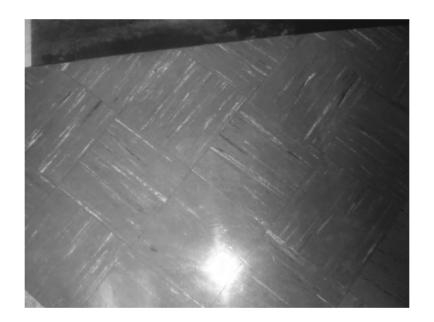
9"x9" Brown Floor Tile w/White & Dark Brown Streaks Sample 7-14B

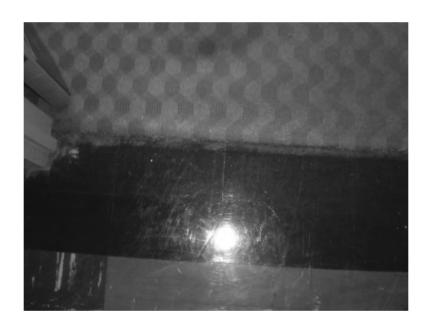
Dark Brown Flooring Border Sample 7 - 28A

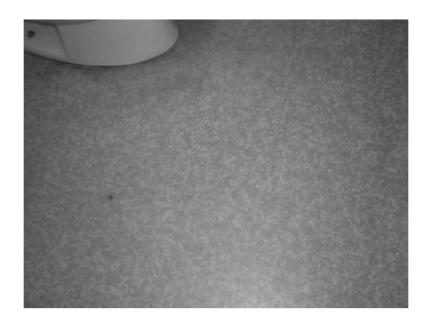
Black Flooring Along Border Sample 7 - 29A

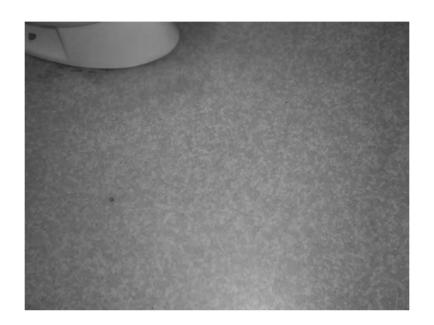
Yellow Linoleum w/Gold Spots Sample 7 - 38A

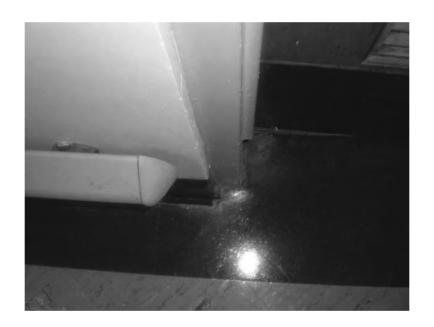
9"x9" Light Brown Vinyl Acrylic Tile with Streaks Sample 9 – 20A

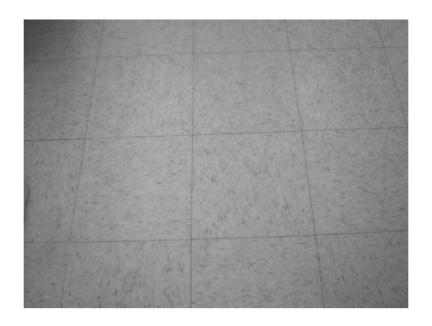
Dark Brown Boarder Vinyl Acrylic Tile Sample 9 - 24A

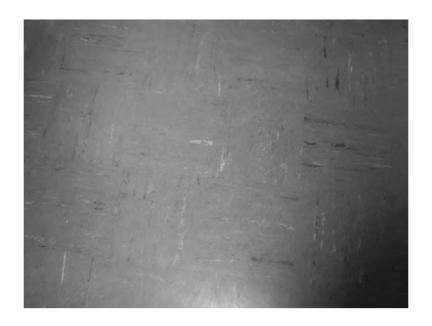
9"x9"' Gray Vinyl Acrylic Tile w Black Streaks Sample 9 - 27A

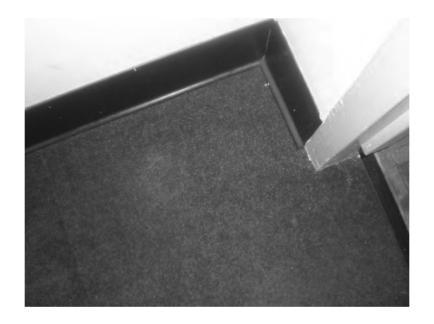
12"x12" Cream Vinyl Floor Tiles w Tan Specks Sample 9 - 31A
